Dannevirke Water Supply Reservoir

Preliminary dam safety advice on abnormal seepage

Prepared for
Taranaki District Council

Prepared by
Tonkin & Taylor Ltd

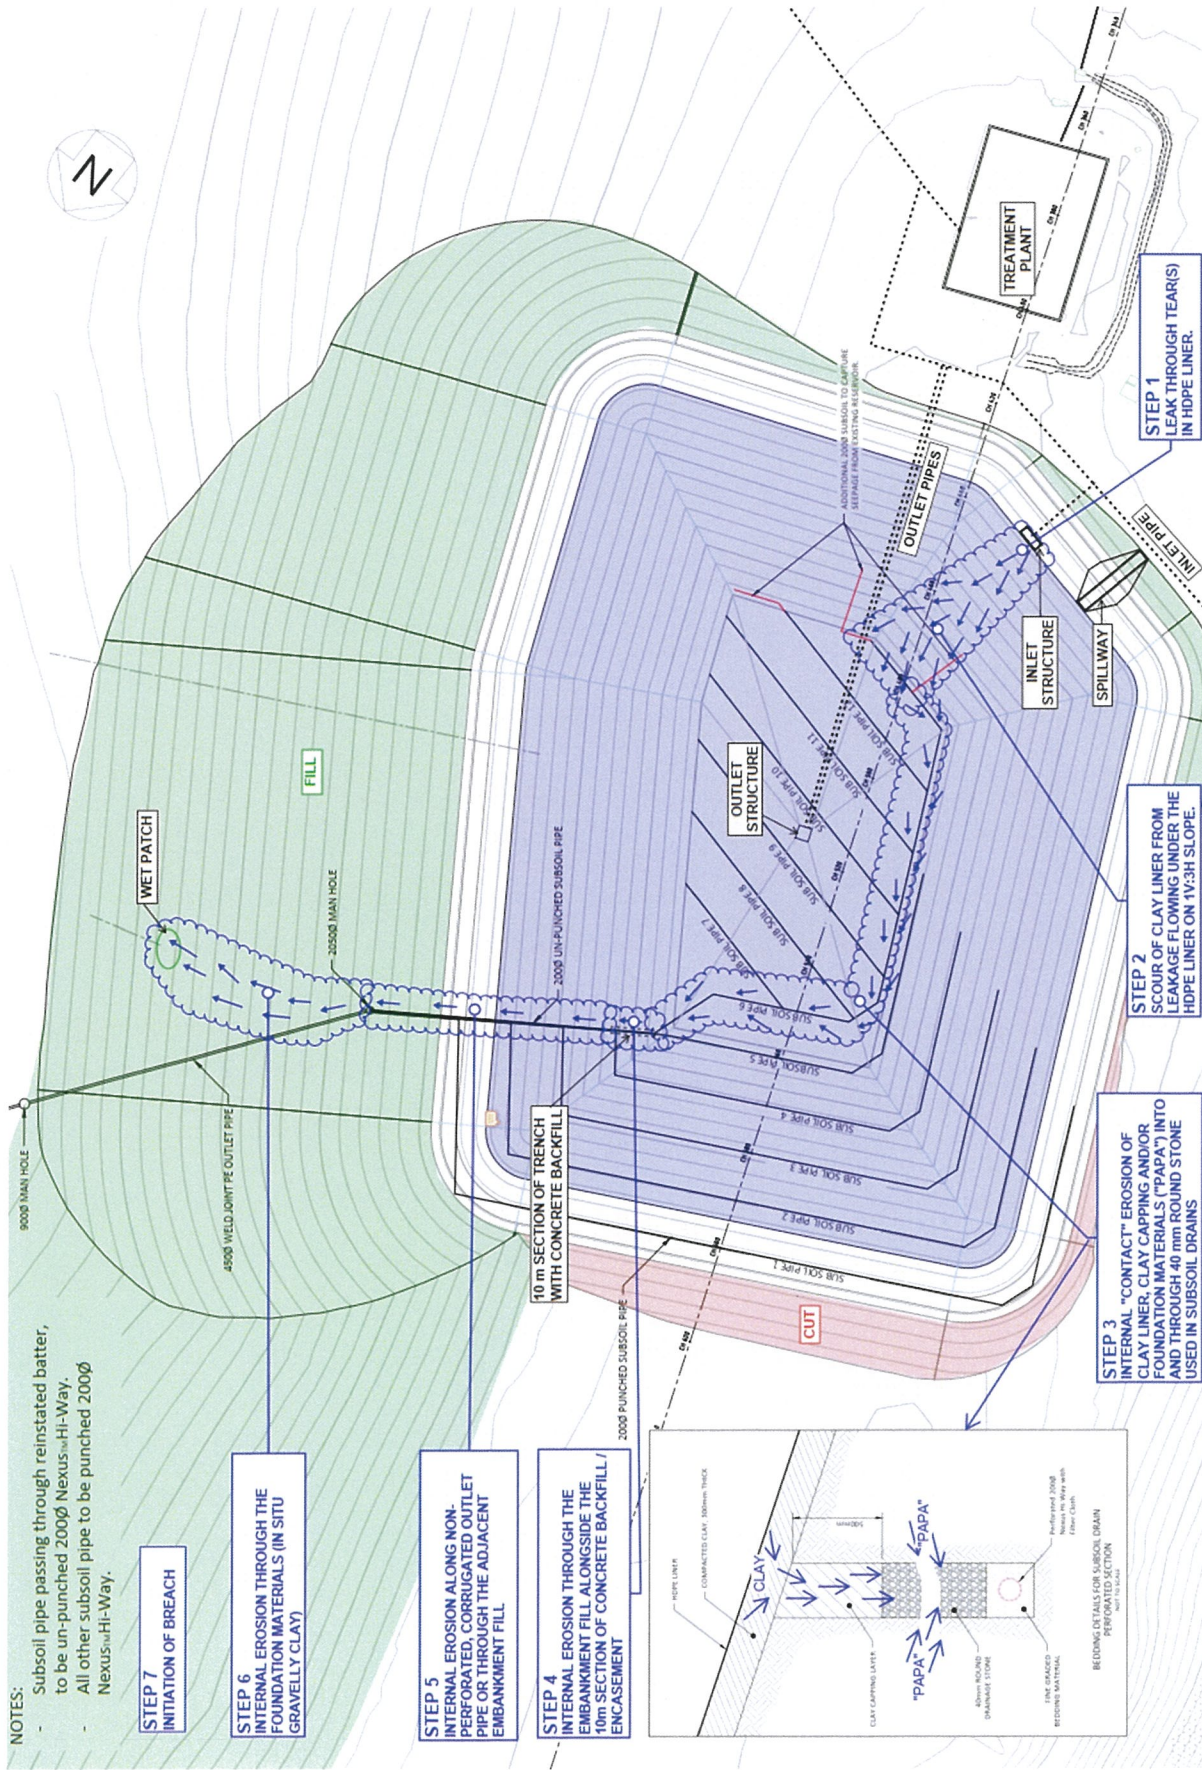
Figure 0.1: Steps in postulated failure mode for subject dam safety issue

The investigation and assessment of the main dam safety issue has identified a potential failure mode that could plausibly explain the abnormal seepage observations. The steps in this failure mode are listed below from upstream to downstream (see also Figure 0.1 for locations):

- 1 A major leak through tear(s) in the HDPE liner, most likely near the inlet structure.
- 2 Scour of the clay liner from the leaked water flowing under the HDPE liner and down the 1V:3H slope of the reservoir.

- 6 Internal erosion through the foundation materials (natural gravelly clay), deviating from the subsoil outlet pipeline at the 2050 mm diameter manhole and daylighting at the “wet patch” on the downstream face of the eastern fill embankment.

- STEP 7**
INITIATION OF BREACH
- STEP 6**
INTERNAL EROSION THROUGH THE FOUNDATION MATERIALS (IN SITU GRAVELLY CLAY)
- STEP 5**
INTERNAL EROSION ALONG NON-PERFORATED, CORRUGATED OUTLET PIPE OR THROUGH THE ADJACENT EMBANKMENT FILL
- STEP 4**
INTERNAL EROSION THROUGH THE EMBANKMENT FILL ALONGSIDE THE 10m SECTION OF CONCRETE BACKFILL/ ENCASEMENT
- STEP 3**
INTERNAL "CONTACT" EROSION OF CLAY LINER, CLAY CAPPING AND/OR FOUNDATION MATERIALS ("PAPA") INTO AND THROUGH 40 mm ROUND STONE USED IN SUBSOIL DRAINS
- STEP 2**
SCOUR OF CLAY LINER FROM LEAKAGE FLOWING UNDER THE HDPE LINER ON 1V:3H SLOPE.
- STEP 1**
LEAK THROUGH TEAR(S) IN HDPE LINER.

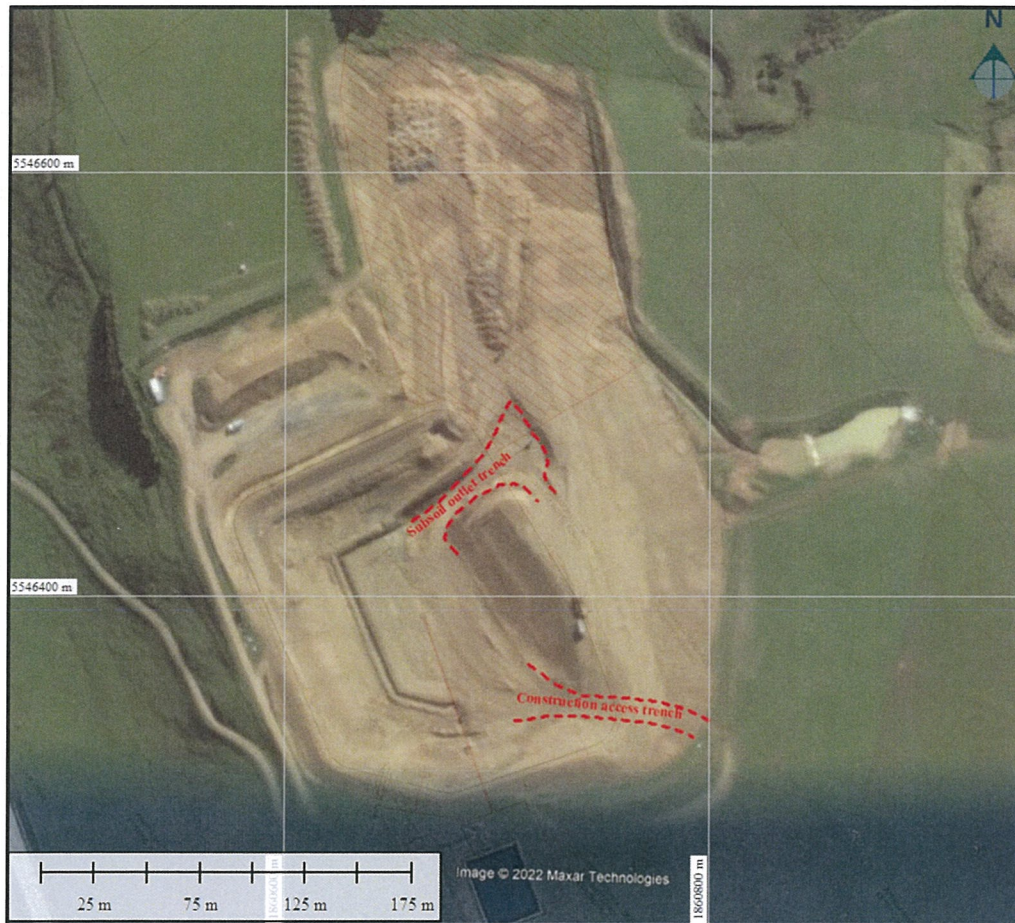
These deeper excavations represent locations where the dam embankment fill is locally higher and the contact with underlying, natural ground is locally lower. If the dam embankment fill is higher permeability than the natural ground, seepage could potentially track along the contact. The localised “valley” shape formed by the trenches could potentially represent a preferred seepage path, and an area that could be more vulnerable to internal erosion. The locally higher fill embankments can also generate larger hypothetical dambreak flows than lower fill embankments (all other factors being equal).

Figure 3.1: Deep trenches cut through eastern fill embankment during construction (photo dated 23 August 2012, taken from Google Earth, overlaid on as-built drawing sheet 2)

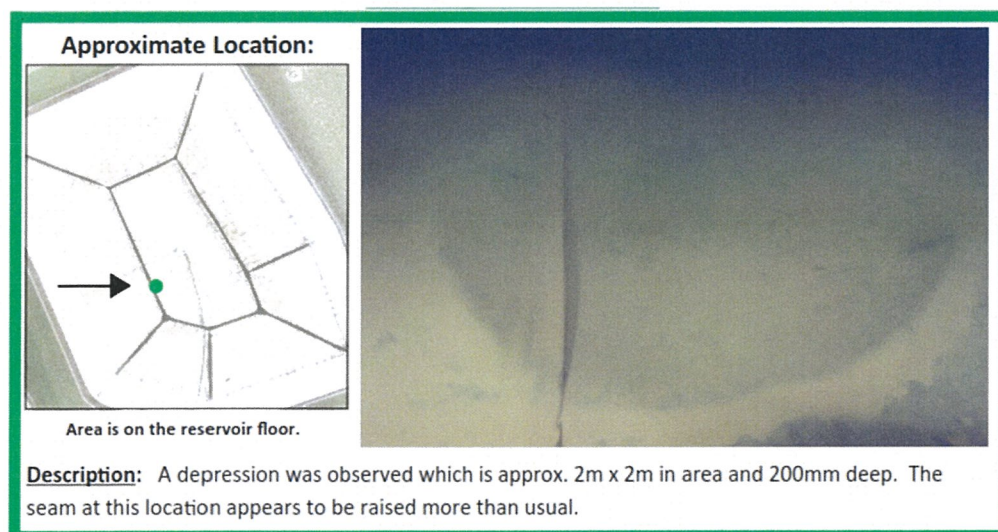
Figure 3.2: Depression (approx. 2 m by 2 m by 200 mm) under liner on western side of reservoir floor (image and description extracted from Bayview Dynamics NZ Report dated 24 August 2021)

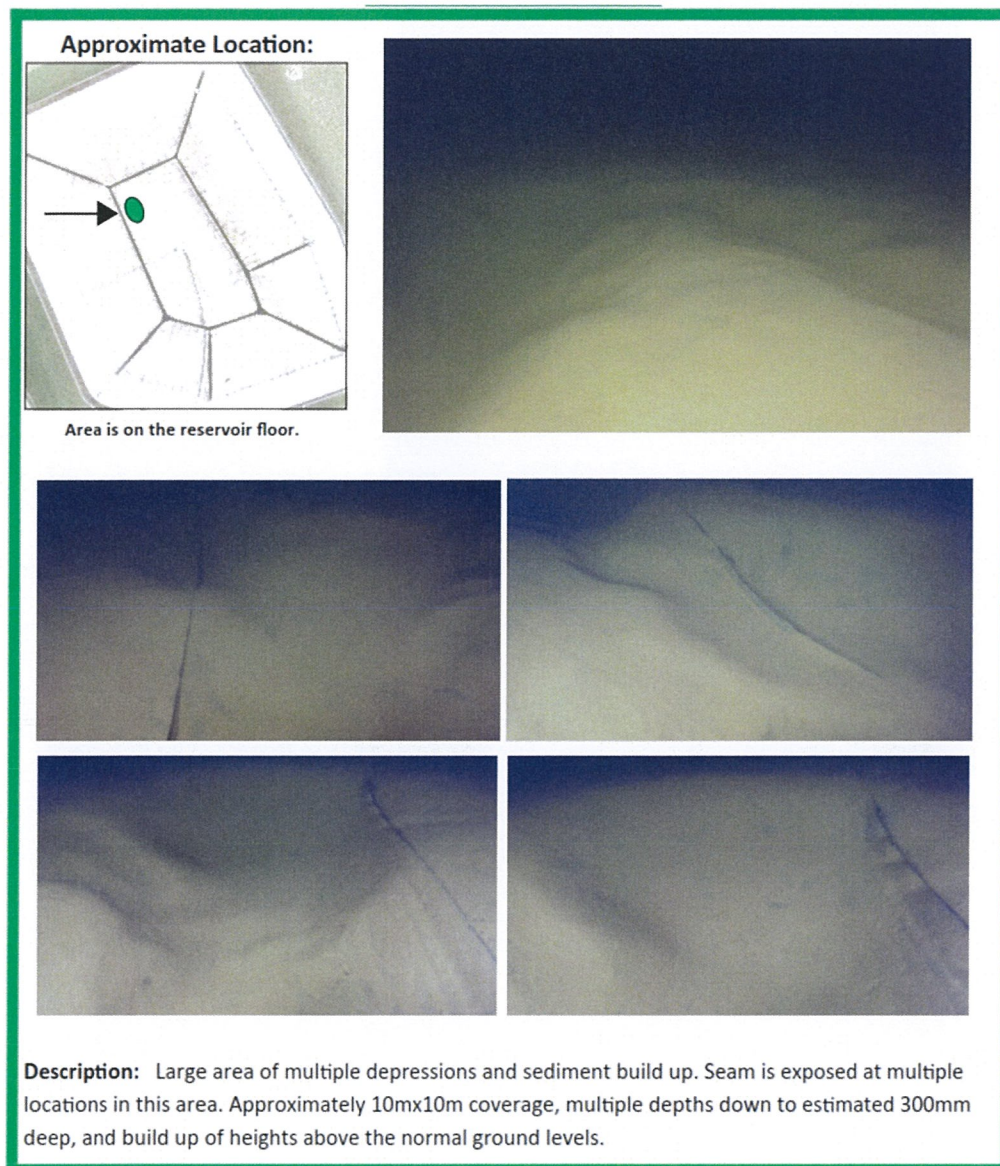
Figure 3.3: Depression (approx. 10 m by 10 m by 300 mm) under liner at north-western end of reservoir floor (image and description extracted from Bayview Dynamics NZ Report dated 24 August 2021)

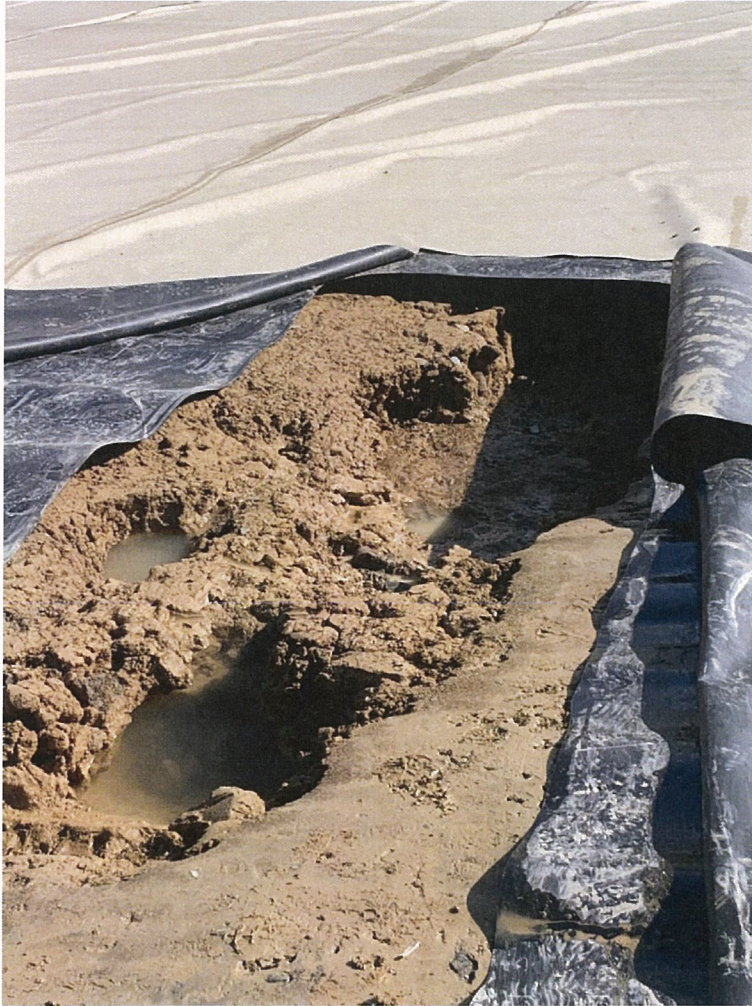
Figure 3.4: Damage below liner near top of slope during 2021 leakage incident

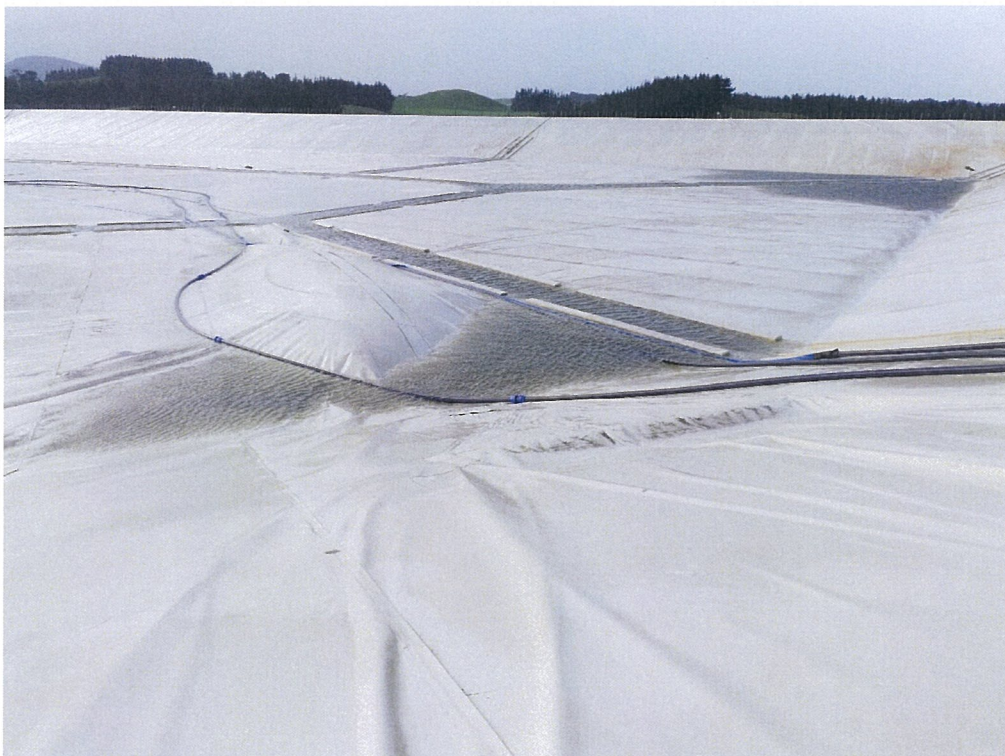
- The upstream (internal) faces of the reservoir were under the floating reservoir cover so were not able to be directly inspected. The cover was visibly “rippling” below the inlet structure where water is released into the reservoir between the cover and liner. Generally (not specifically at the inlet structure), the cover is wrinkled and buckled in places. There is evidence of abrasion damage near the dam crest, which TDC advised is likely caused by the westerly wind pushing the cover over to rub against the anchor fixings on the dam crest.

Figure A 1: Reservoir cover noting depression under the cover near the middle of the photo is the location of the inlet

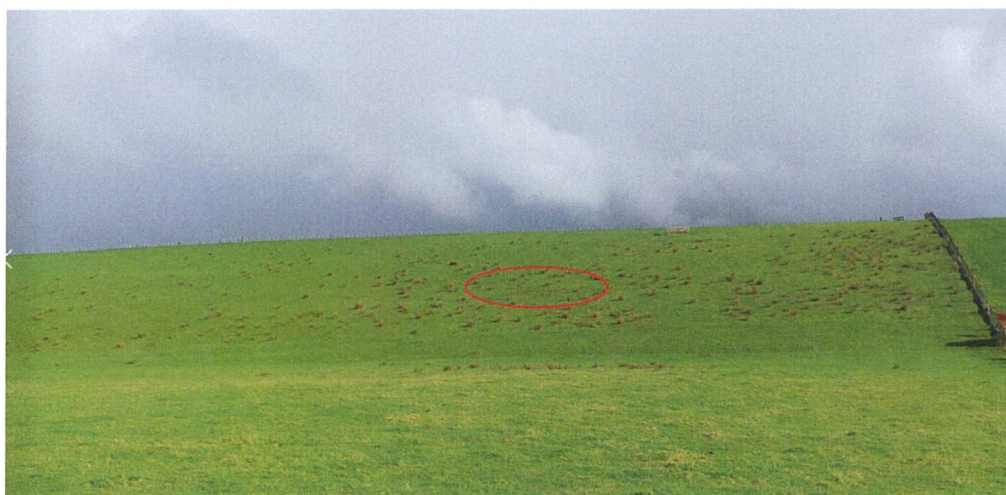
- The downstream face of the eastern fill embankment was uneven and wet underfoot in many places and at all levels. The wet soil conditions have persisted for enough time for reeds to grow across the full downstream face, also at all levels.

Figure A 2: Downstream face of the eastern embankment - note "wet patch" in middle of photo

We also recommend daily visual surveillance of the “wet patch” on the downstream face of the eastern fill embankment. This should involve:

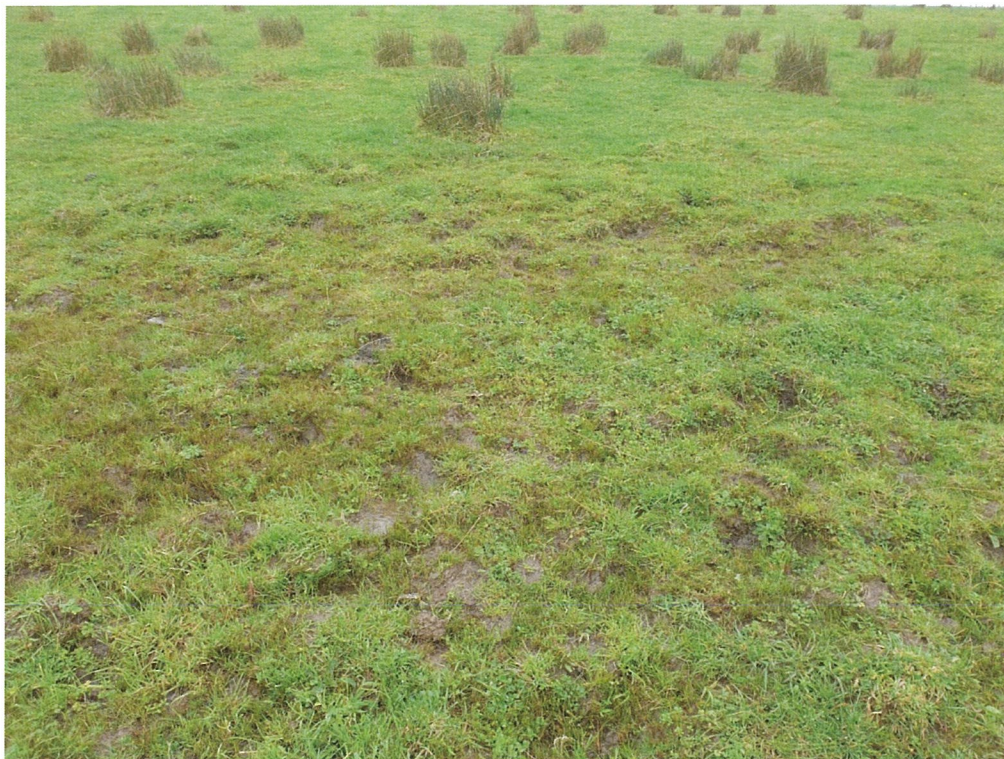
- c The different vegetation at the “wet patch”, already described in Section 3.2.2, indicates long-term saturated conditions. The long-term saturation at the “wet patch” could indicate a preferential seepage path created by internal erosion. However, this is only one possible mechanism. There could alternatively be preferential seepage through a naturally higher permeability horizon in the foundation that is stable i.e., not subject to ongoing deterioration and increases in permeability due to internal erosion. Another possibility is that the seepage could comprise rainwater that has infiltrated the embankment fill and is directed back to the surface by the contact with lower permeability foundation materials or lower permeability horizons perched within the fill.

Figure A 3: Close up photo of the “wet patch”

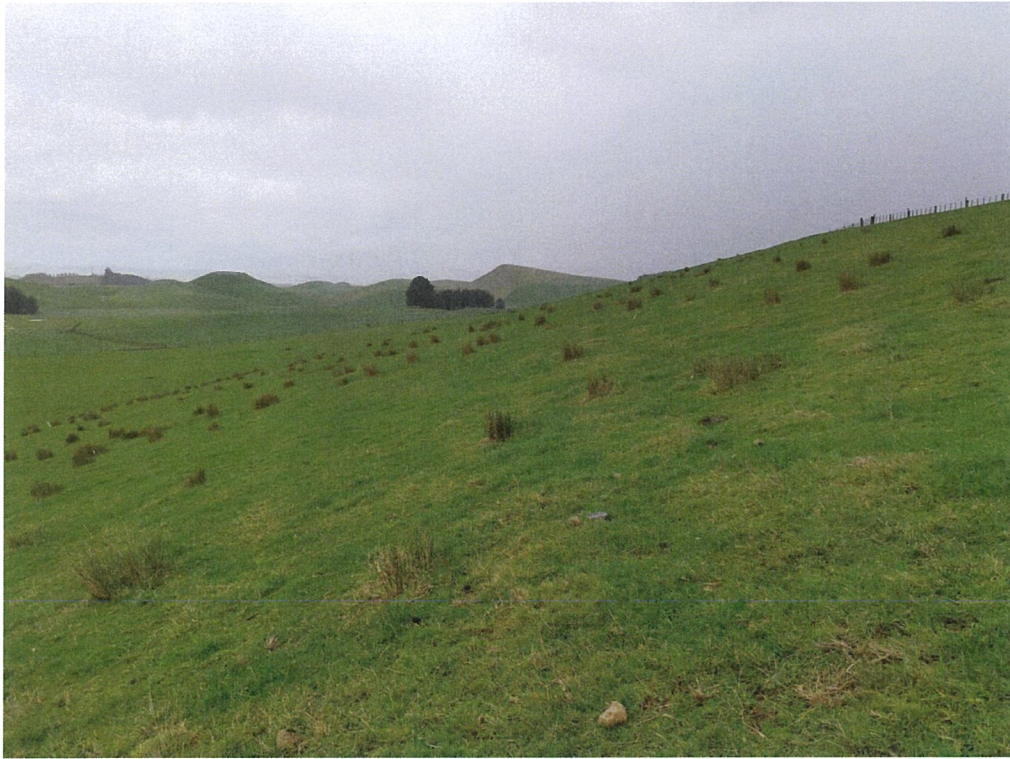
Figure A 4: Downstream face of the eastern embankment – looking south

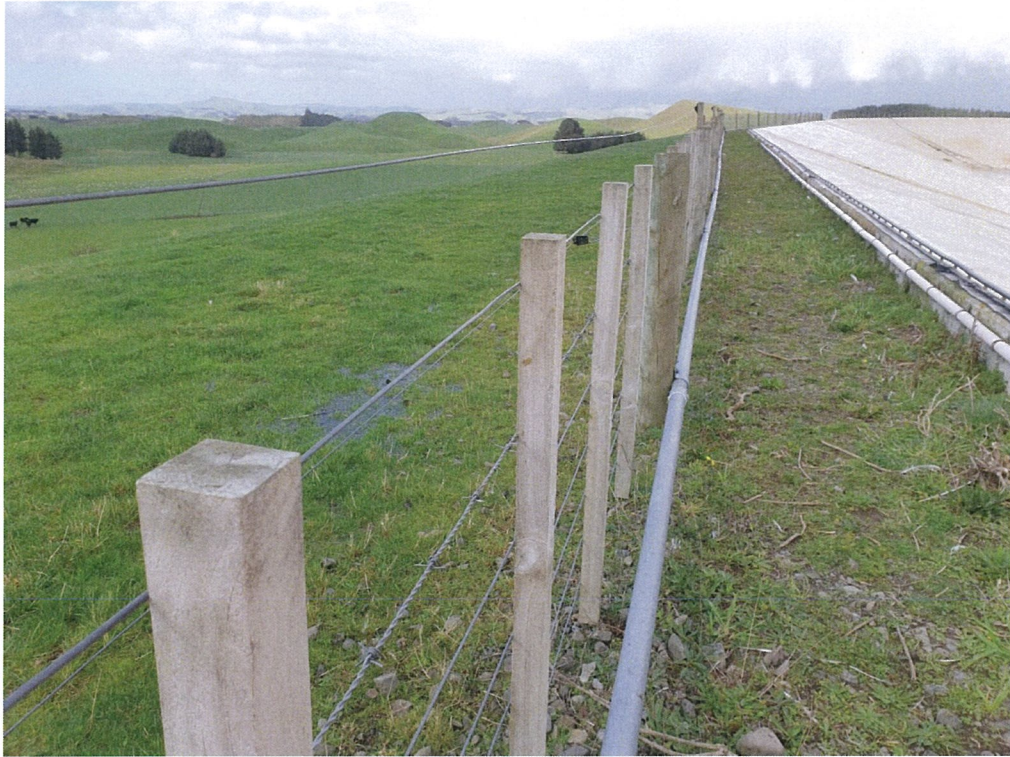
- A less pronounced but similar “wet patch” was observed further south at a similar elevation.
- Water was observed ponding on the dam crest of the eastern fill embankment and in the field on the lower terrace below the embankment toe. TDC advised that the ponding on the field had been present for a few weeks prior to the site inspection.

Figure A 6: Water ponding on crest of the eastern embankment

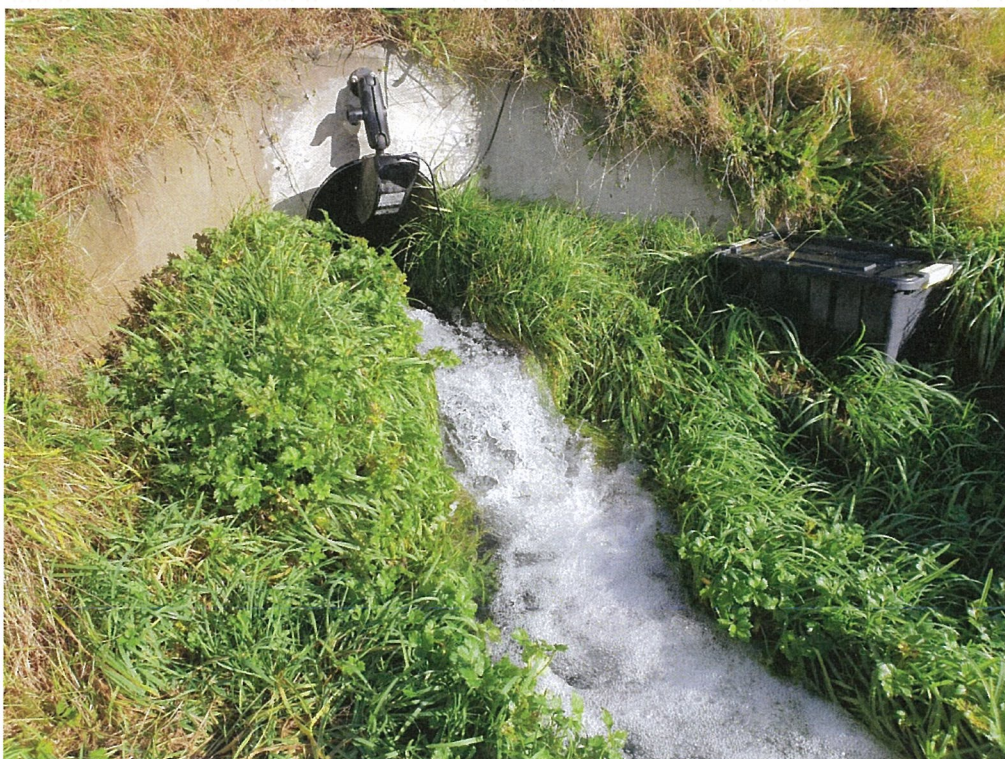
- d As already described in Sections 3.2.2 and 3.2.3, the rate of subsoil seepage discharge is considered abnormally fast for a dam of this size, typical allowances for liner seepage¹², and expected natural groundwater seepage¹³. Moreover, based on the drain capacity¹⁴ and assumption that most of the subsoil seepage is conveyed solely via the lowest subsoil drain, it is possible that this subsoil drain is slightly pressurised, which further increases the risk of internal erosion.

Figure A 7: Seepage flow at subsoil drain outlet to stream

We recommend improving how discharge from the subsoil drainage network is monitored as follows:

- The portion of subsoil seepage flow that is pumped back into the reservoir should be monitored in the same manner (i.e., frequency and accuracy) as subsoil discharge at the stream outlet. Both the subsoil seepage pumped back and discharged at the stream should be recorded separately, and *also* summed to track total subsoil seepage. Furthermore, measurement of the subsoil seepage pumped back is an input for analysing the reservoir water balance (inflows, outflows, storage), which is valuable to identify leakage.
