From: Allie Dunn
Sent: Friday, 8 August 2025 4:58 pm
To: [REDACTED]
Subject: CM: Response to request for information re Dannevirke Impound Supply Reports
Attachments: bay dynamics report rov drone submersible - dannevirke impounded water supply laws rd ~ water survey report 24 august 2021 (002)(d22_14830).pdf

Laws Rd Reservoir In Water Survey

24 August 2021

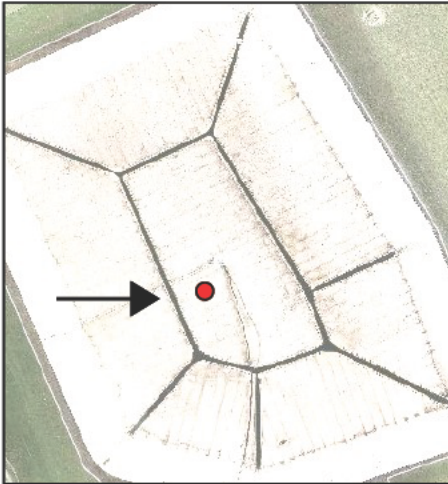
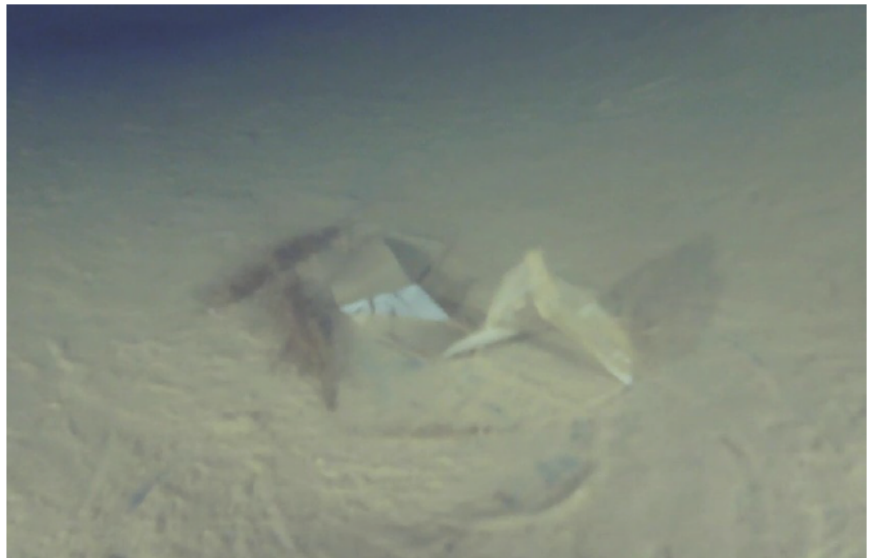
Debris Item 01

Item is on the reservoir floor.

Description: It appears to be some kind of thin plastic film wrapper

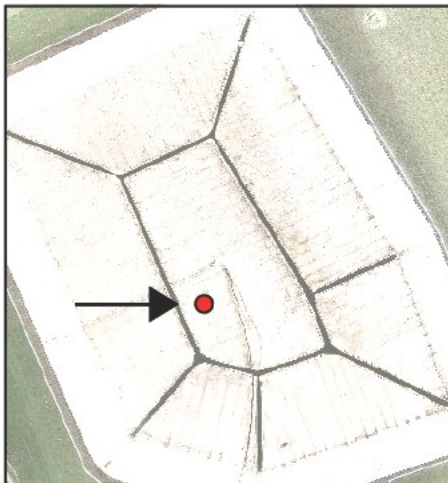
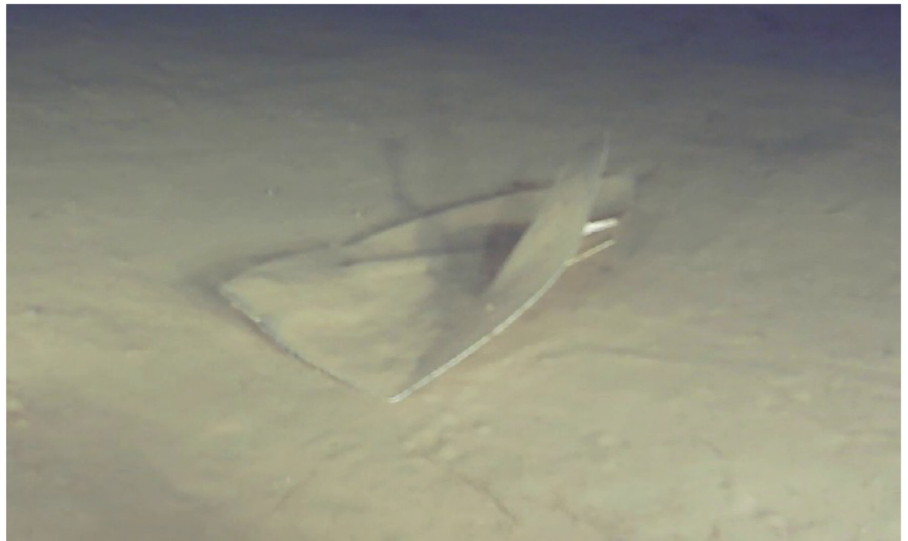
Debris Item 02

Item is on the reservoir floor.

Description: It appears to be offcuts from the cover membrane.

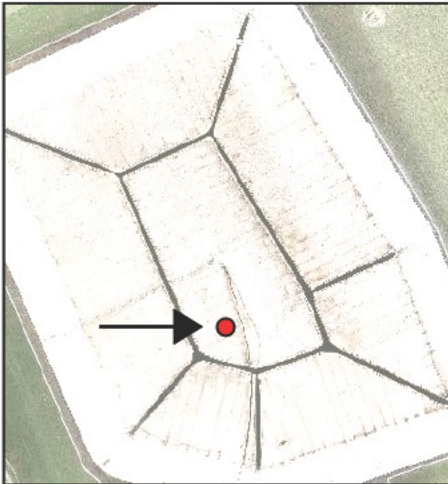
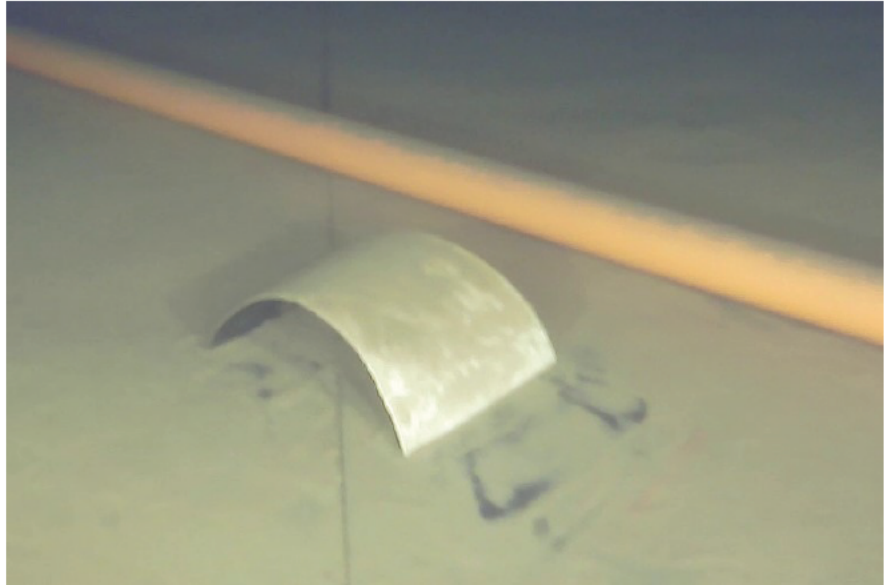
Debris Item 03

Item is on the reservoir floor.

Description: It appears to be offcuts from the cover membrane.

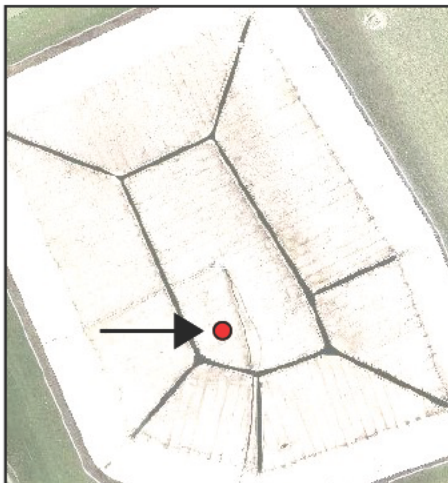
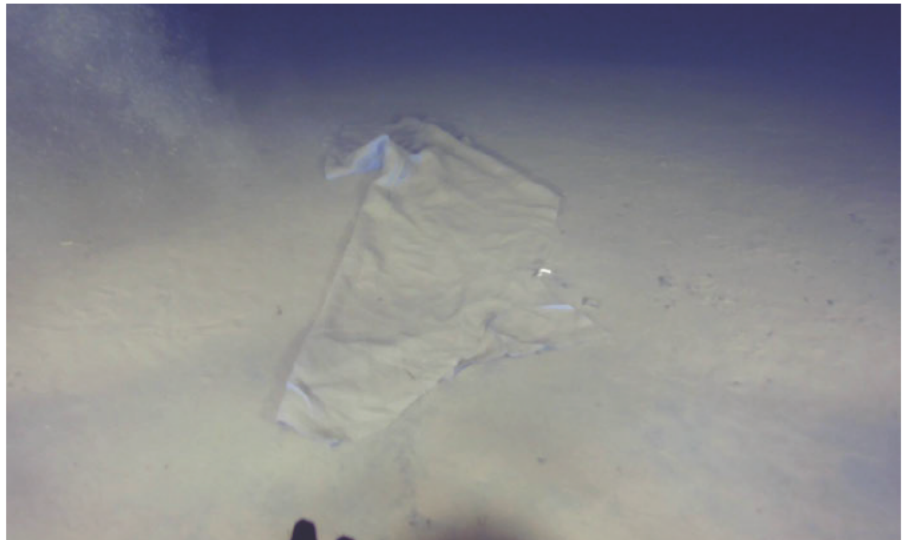
Debris Item 04

Item is on the reservoir floor.

Description: It appears to be a piece of soft fabric cloth, approximate size 1m long.

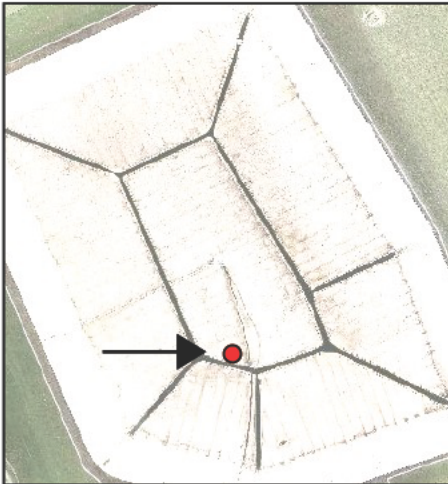
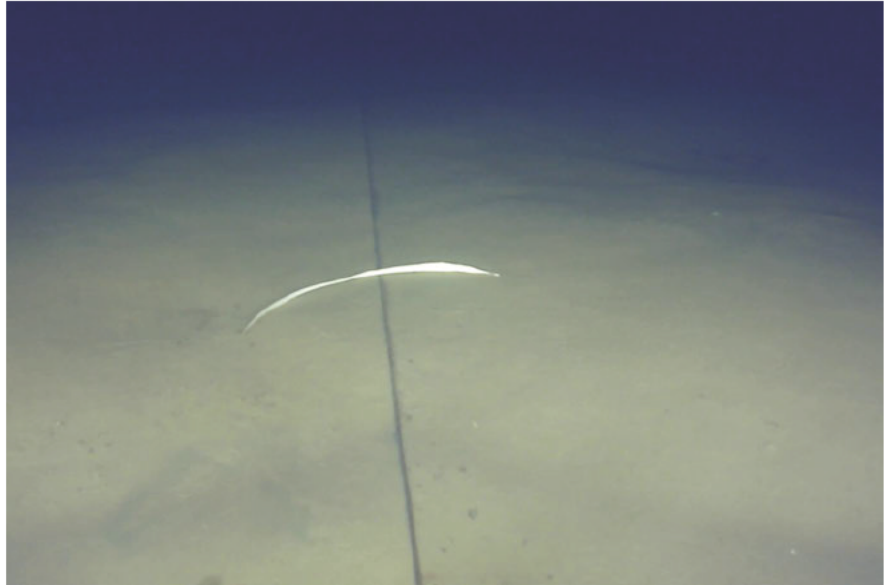
Debris Item 05

Item is on the reservoir floor.

Description: It appears to be offcuts from the cover membrane.

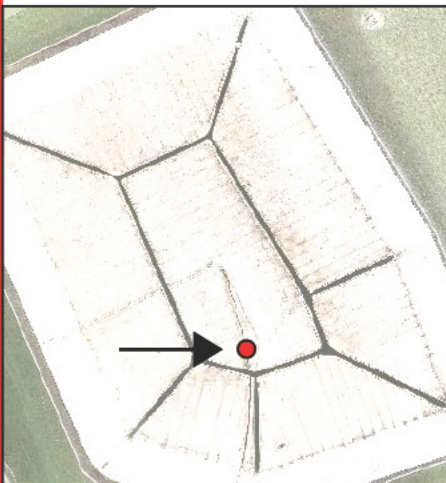
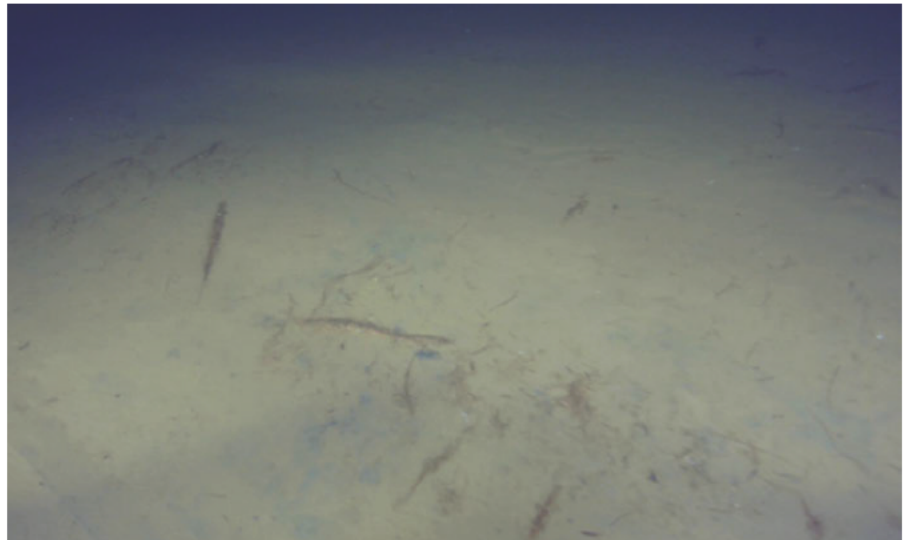
Debris Item 06

Item is on the reservoir floor.

Description: It appears to be various items of foliage, covering an area approx. 5m x 5m.

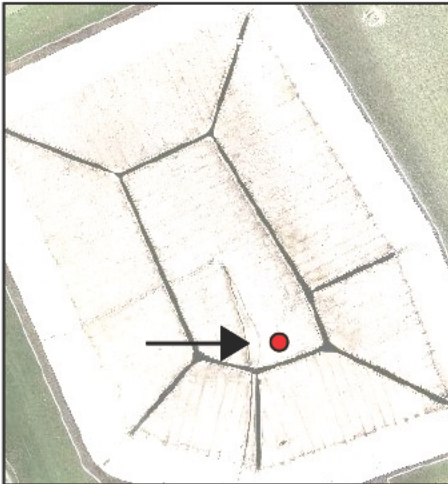
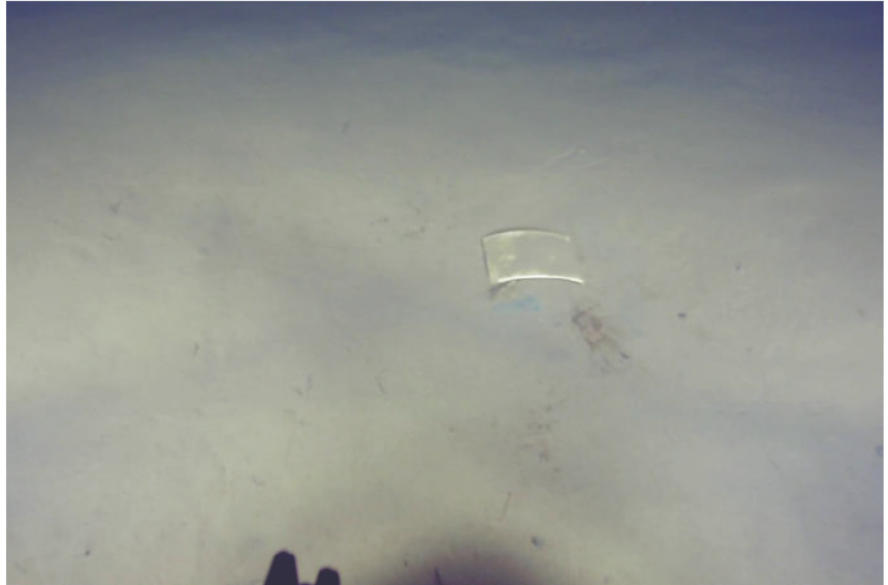
Debris Item 07

Item is on the reservoir floor.

Description: It appears to be offcut / tag from the cover membrane.

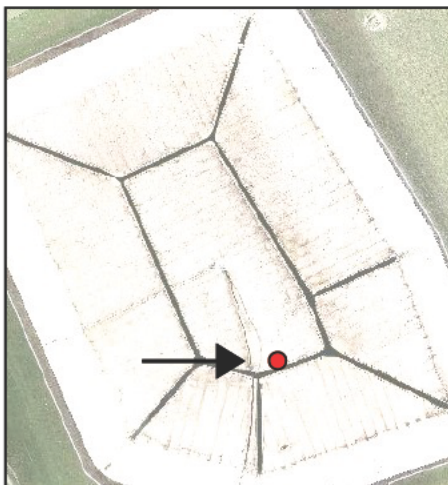
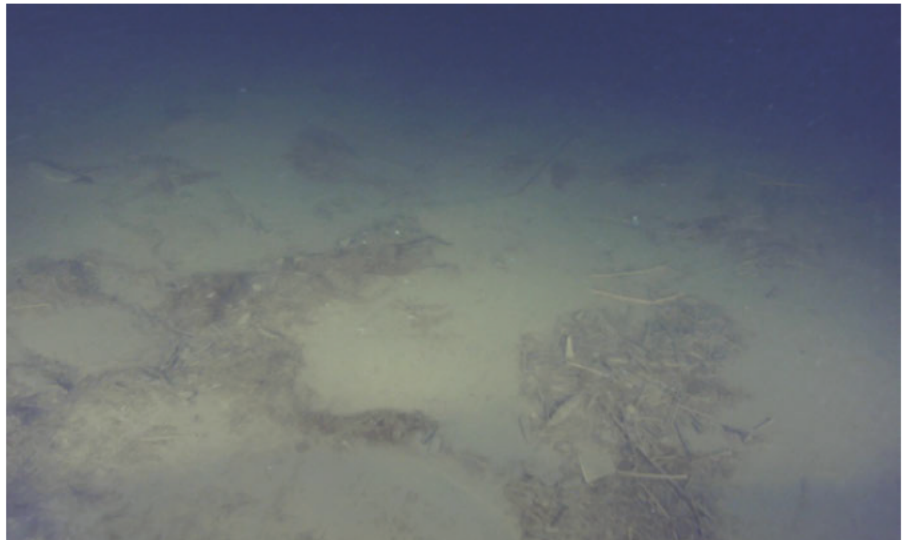
Debris Item 08

Item is on the reservoir floor.

Description: It appears to be various items of foliage, covering an area approx. 10m x 10m.

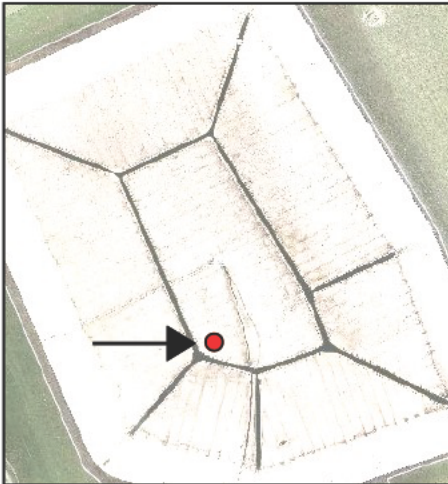
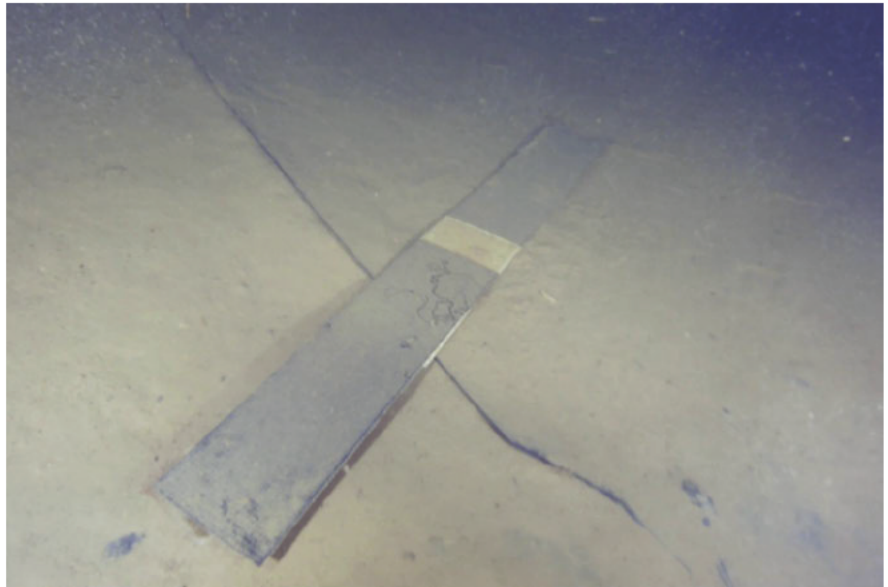
Debris Item 09

Item is on the reservoir floor.

Description: It appears to be an offcut from the cover membrane.

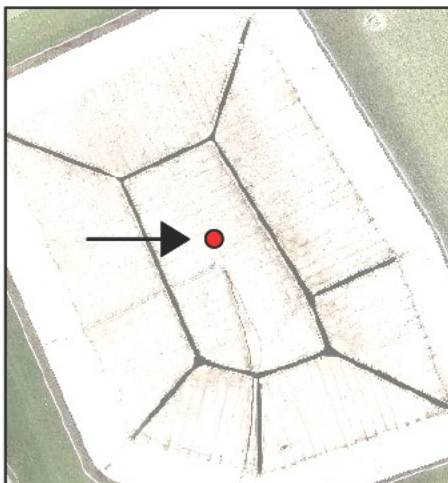
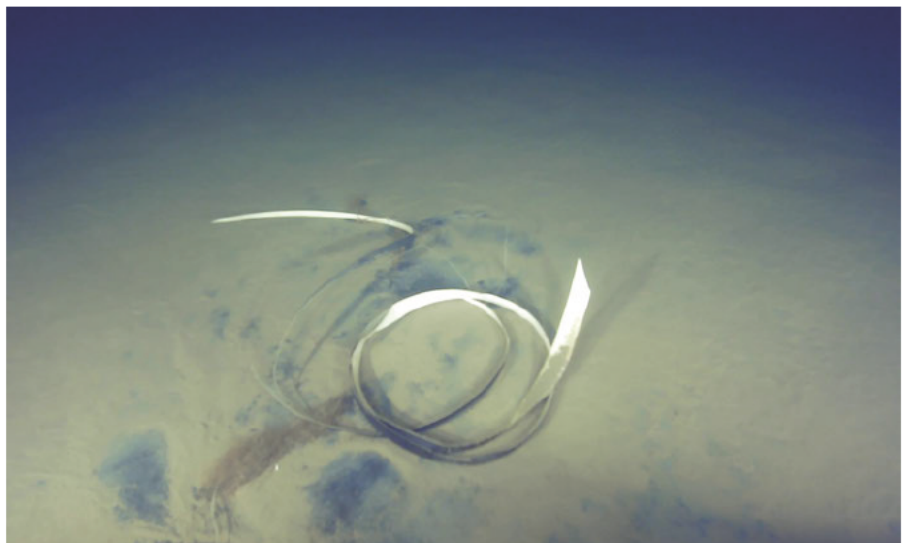
Debris Item 10

Item is on the reservoir floor.

Description: It appears to a coil of offcuts from the cover membrane.

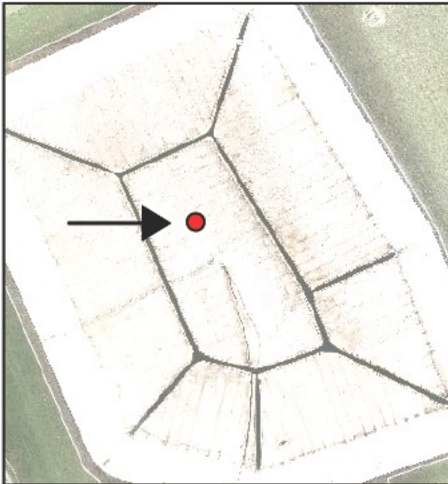
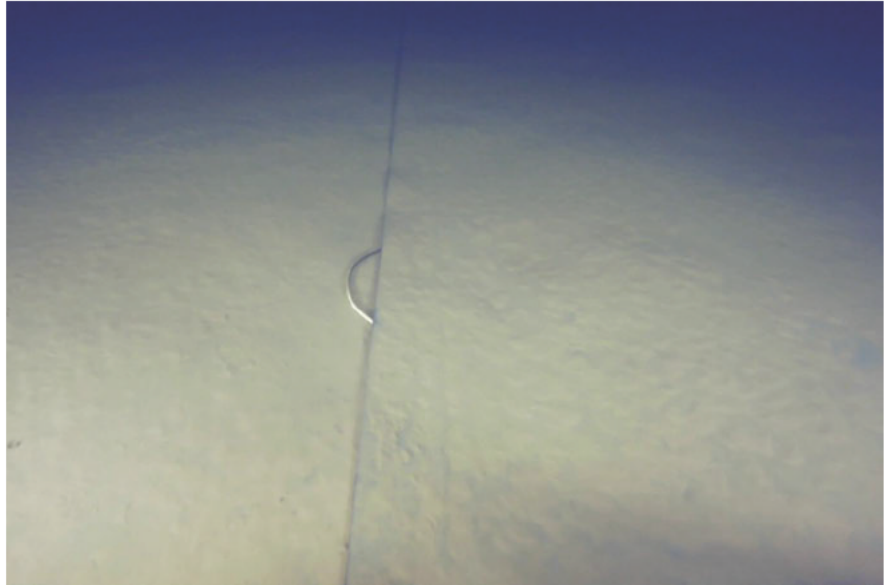
Debris Item 11

Item is on the reservoir floor.

Description: It appears to be an offcut from the cover membrane.

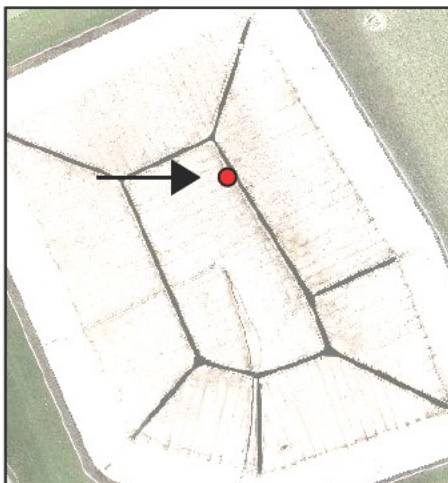
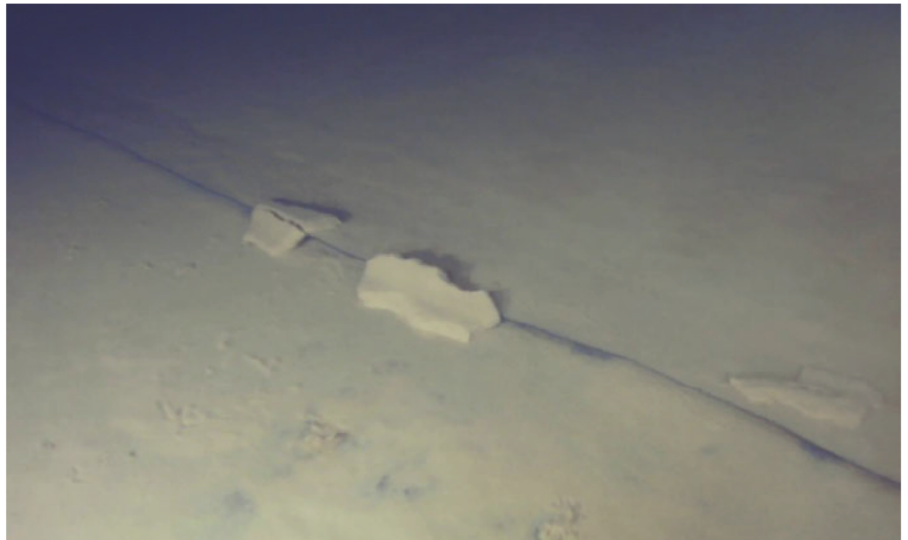
Debris Item 12

Item is on the reservoir floor.

Description: It appears to be solidified sediment which has become dislodged from the inclines.

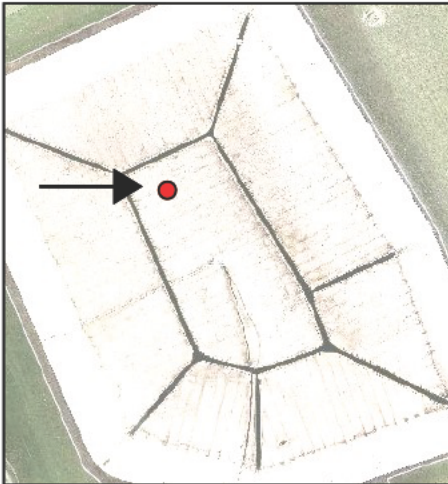
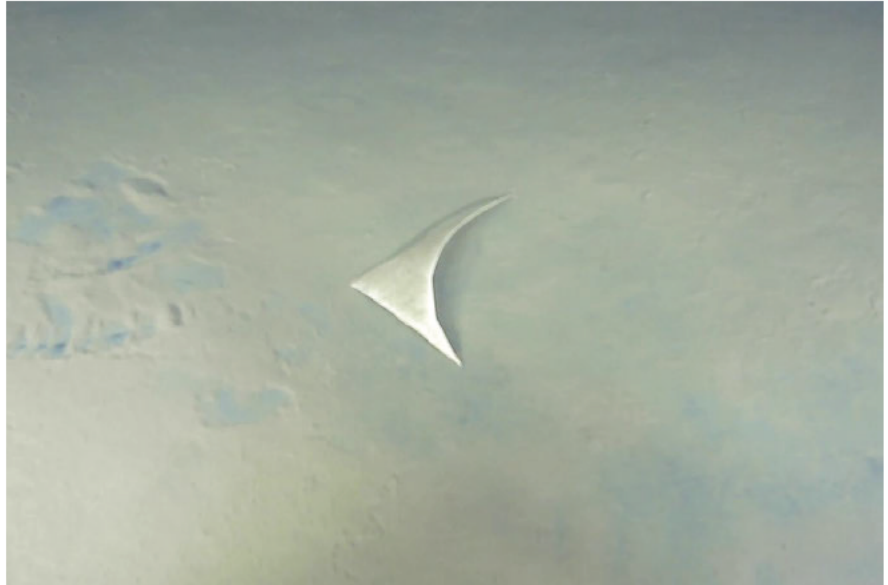
Debris Item 13

Item is on the reservoir floor.

Description: It appears to be an offcut from the cover membrane.

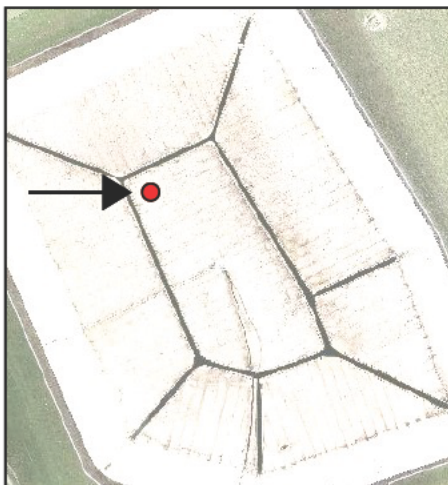
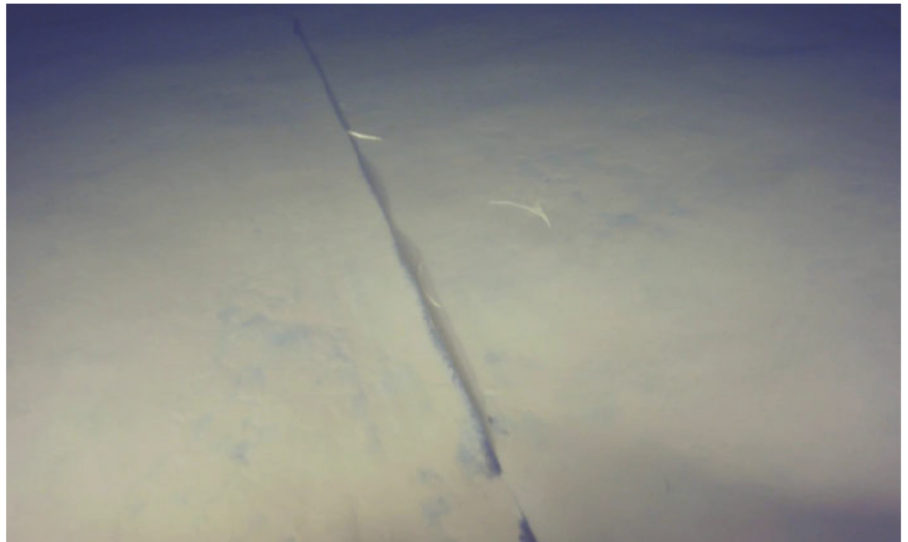
Debris Item 14

Item is on the reservoir floor.

Description: It appears to be multiple slivers of membrane offcuts

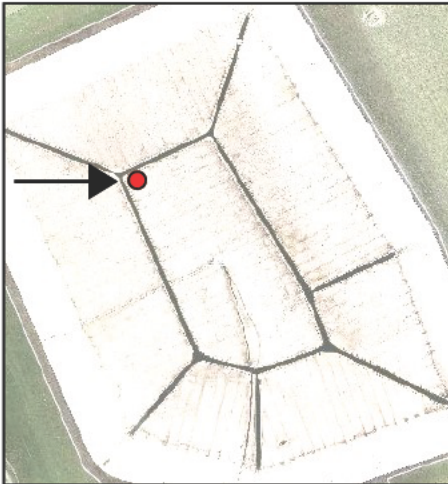
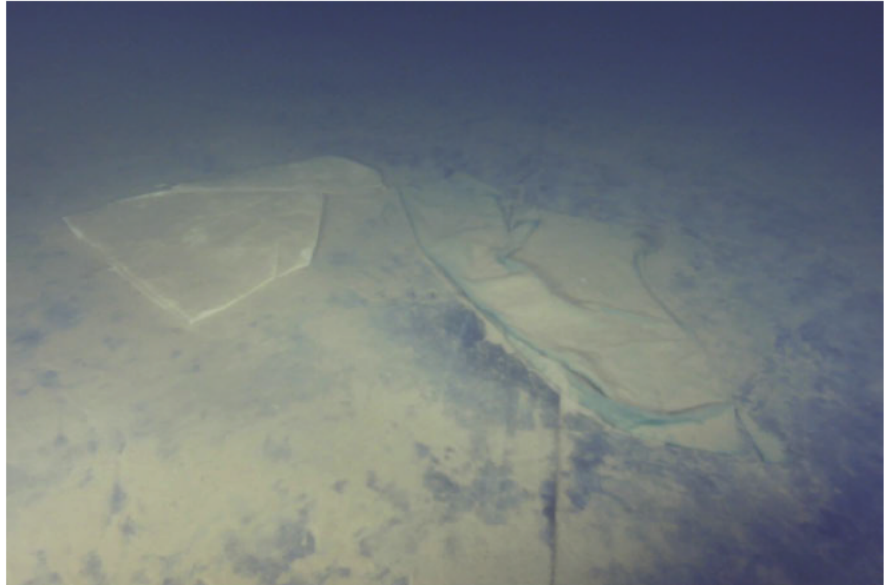
Debris Item 15

Item is on the reservoir floor.

Description: It appears to two different pieces of soft fabric cloth.

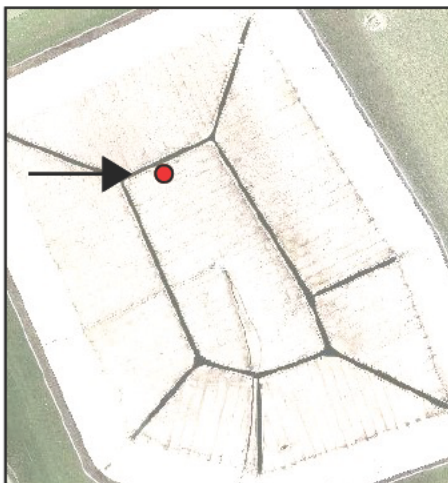
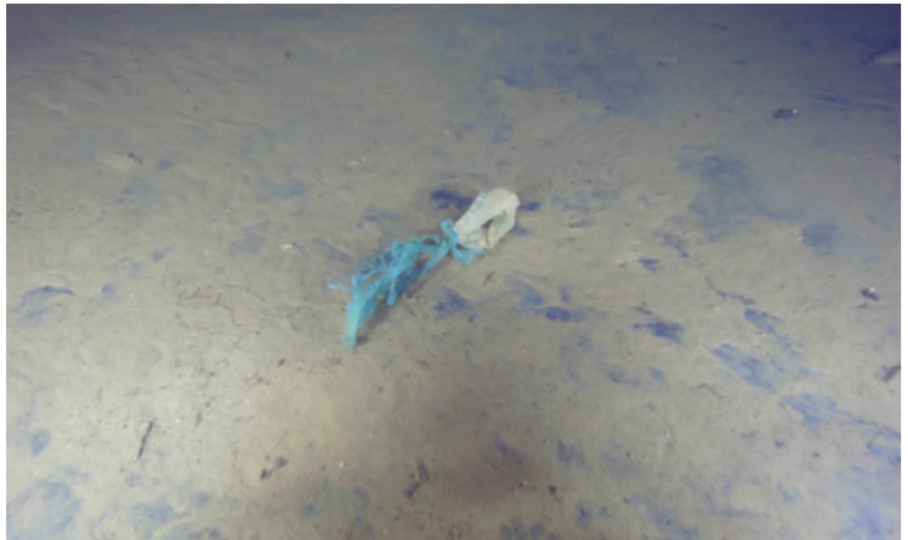
Debris Item 16

Item is on the reservoir floor.

Description: It appears to be fabric tie from a possible carry bag.

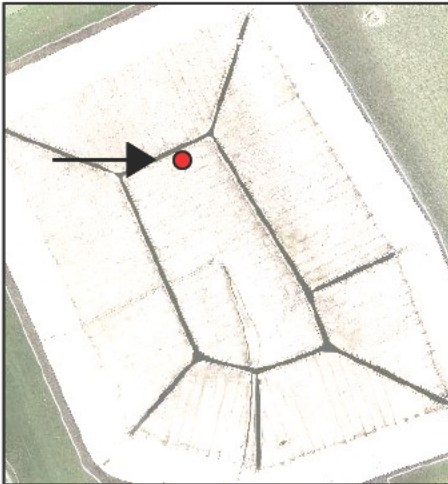
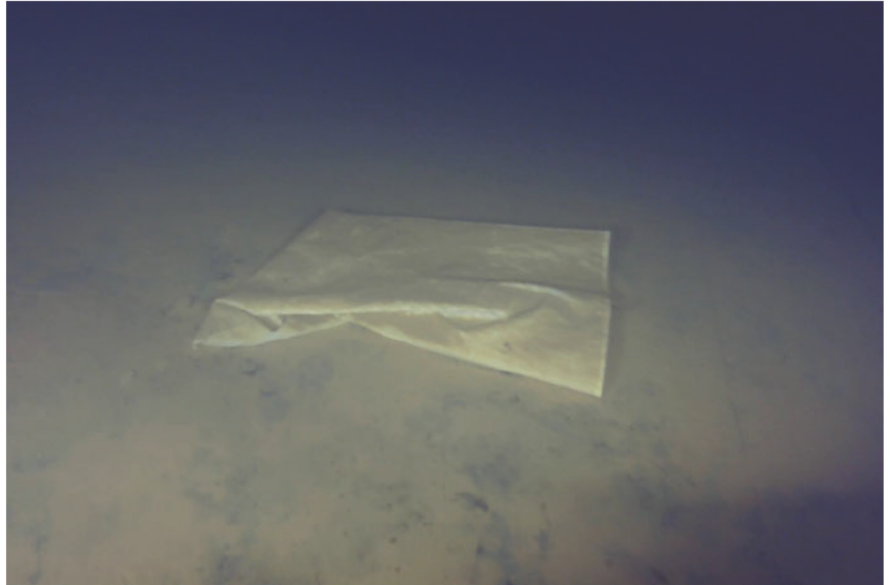
Debris Item 17

Item is on the reservoir floor.

Description: It appears to a fabric carry bag, closed at one end, open at the other.

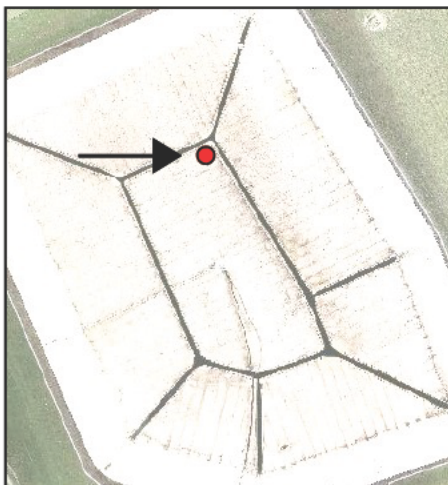
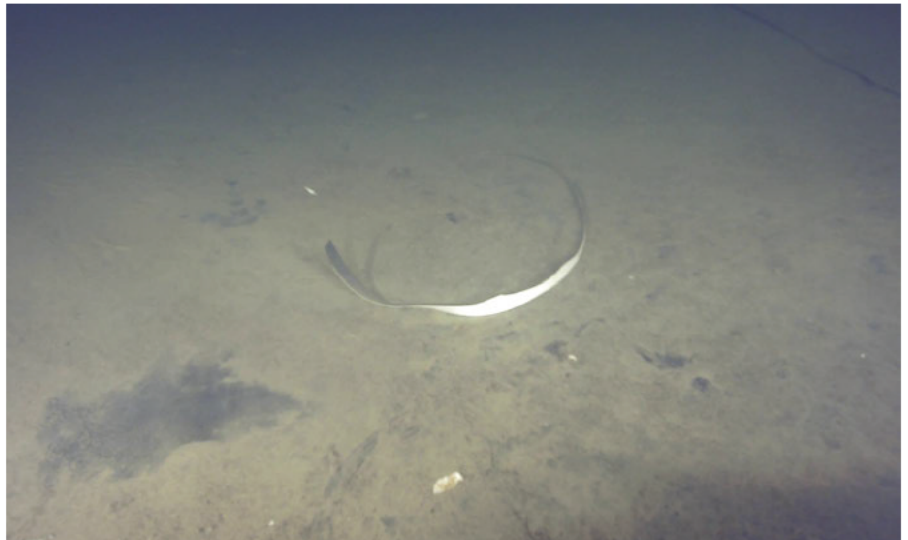
Debris Item 18

Item is on the reservoir floor.

Description: It appears to sliver of membrane offcut

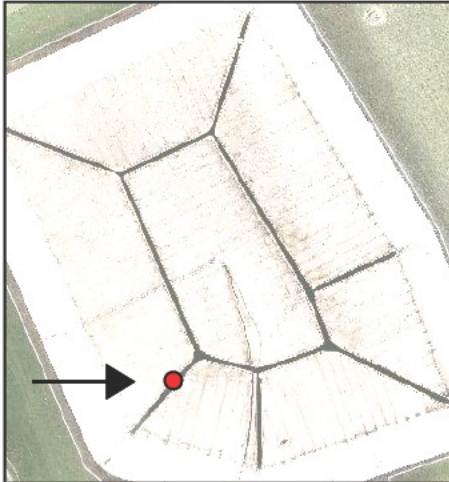
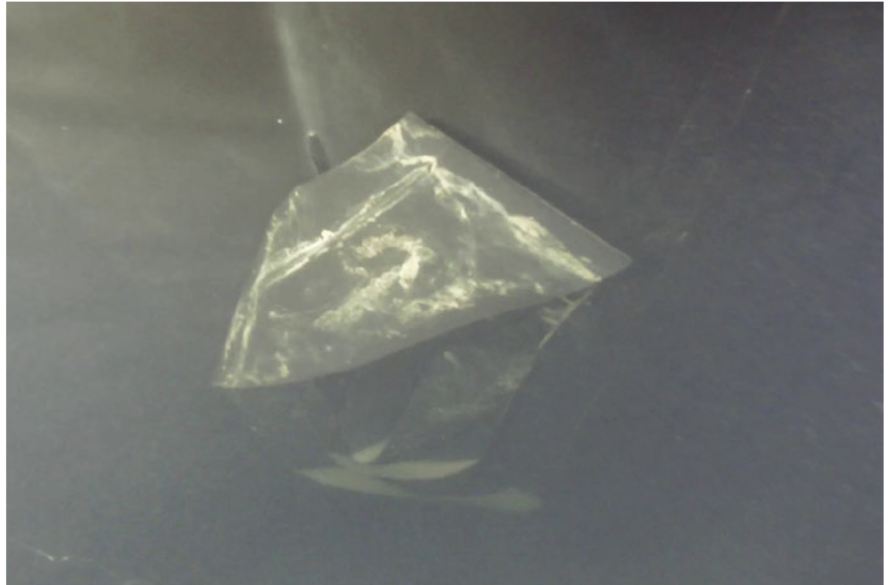
Debris Item 19

Item is floating under the cover

Description: It appears to be offcut membrane which is floating up against the cover.

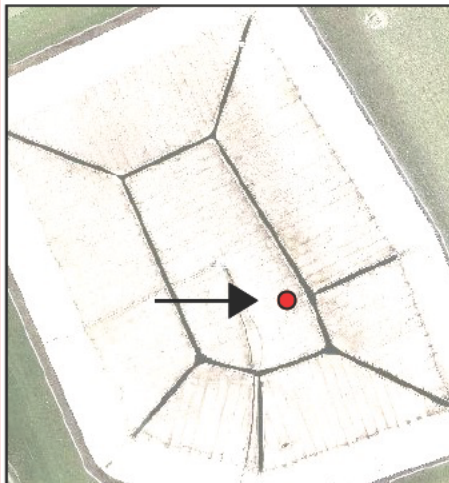
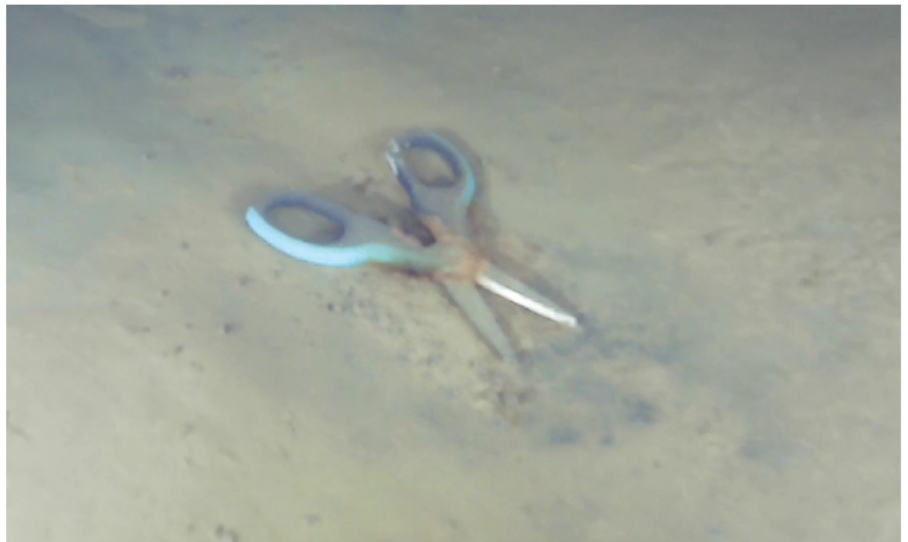
Debris Item 20

Item is on the reservoir floor.

Description: It appears to be a pair of scissors.

These Scissors were removed from the reservoir by the ROV at the time of the survey due to the potential cutting hazard they presented.

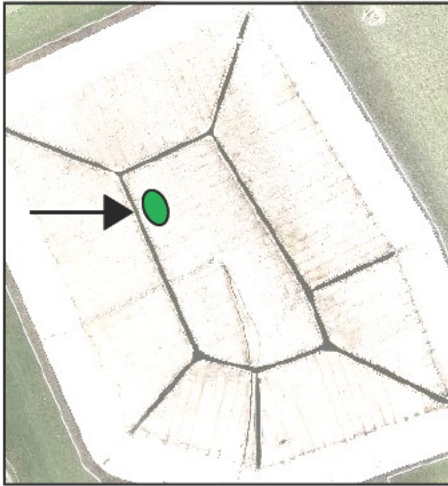
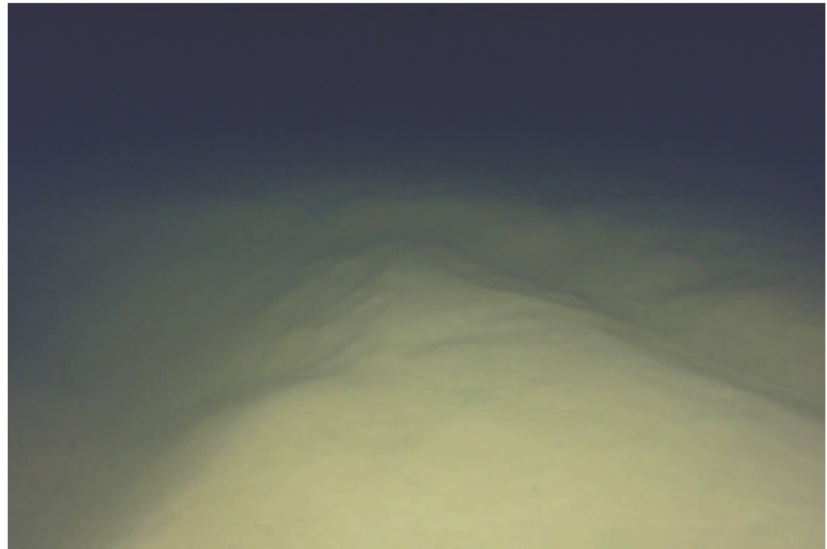
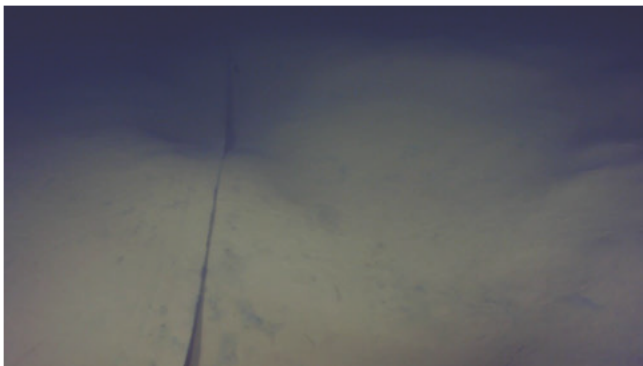
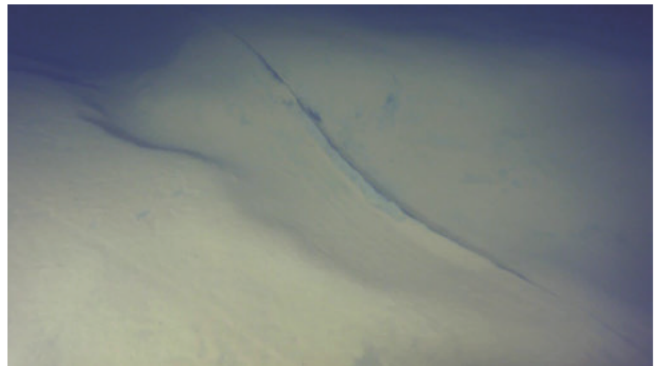
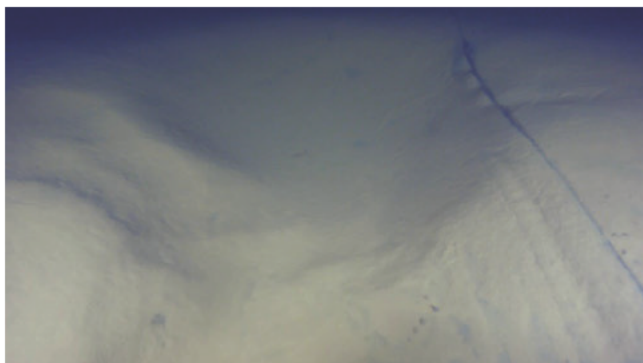
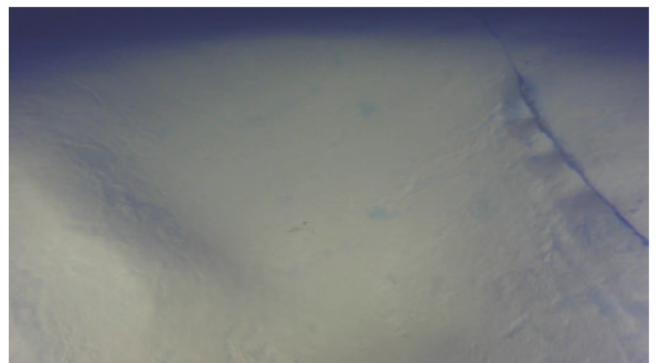
Geological Item 01

Area is on the reservoir floor.

Description: Large area of multiple depressions and sediment build up. Seam is exposed at multiple locations in this area. Approximately 10mx10m coverage, multiple depths down to estimated 300mm deep, and build up of heights above the normal ground levels.

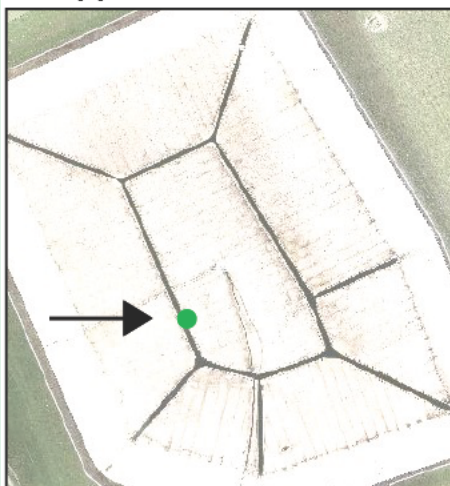
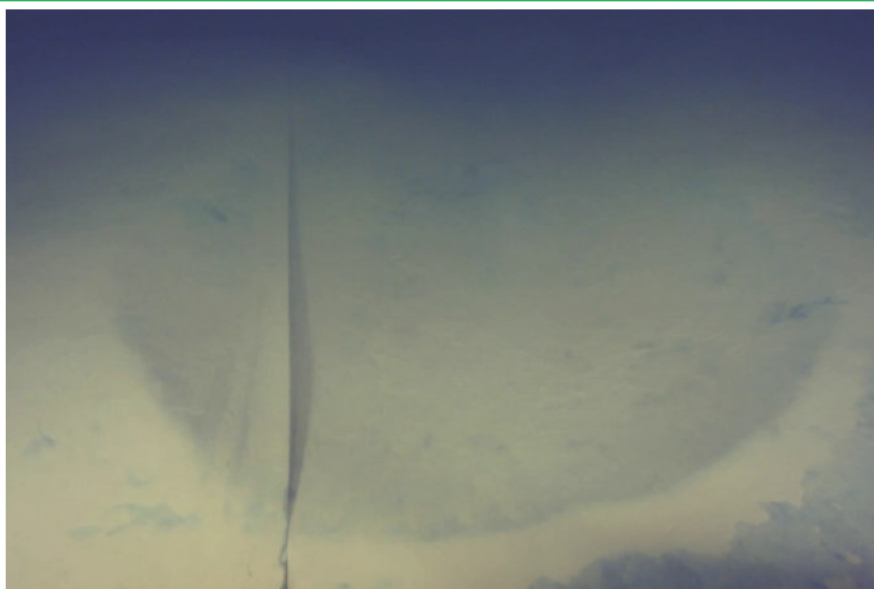
Geological Item 02

Area is on the reservoir floor.

Description: A depression was observed which is approx. 2m x 2m in area and 200mm deep. The seam at this location appears to be raised more than usual.

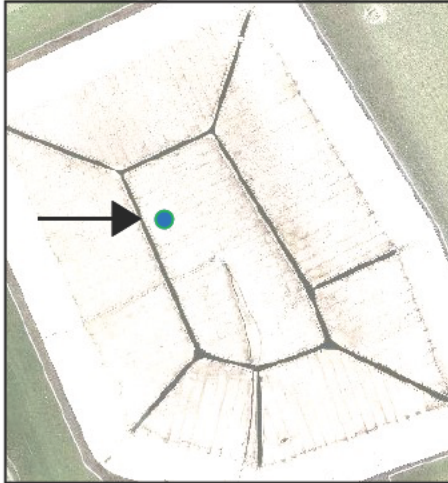
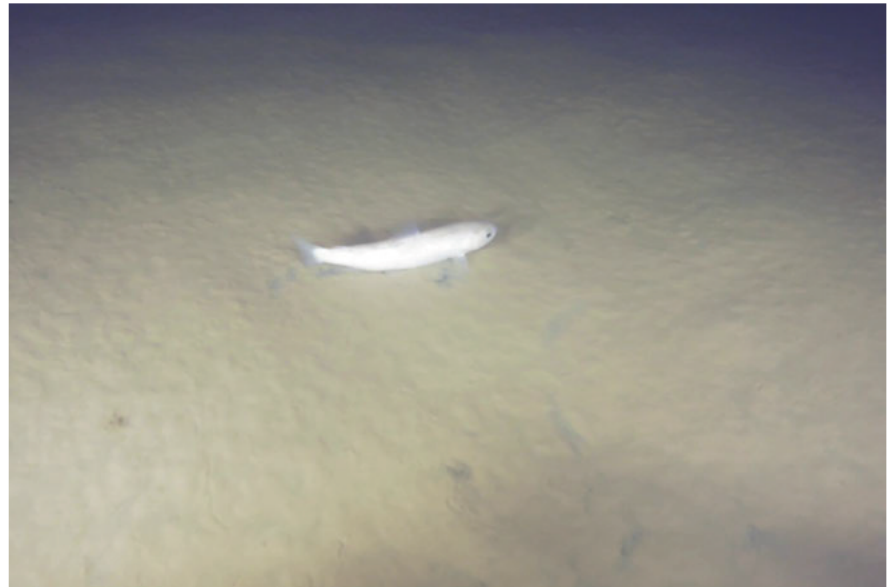
Marine Life Item 01

Area is on the reservoir floor.

Description: Fish, unknown species, observed. Approximate length 100mm - 120mm long.

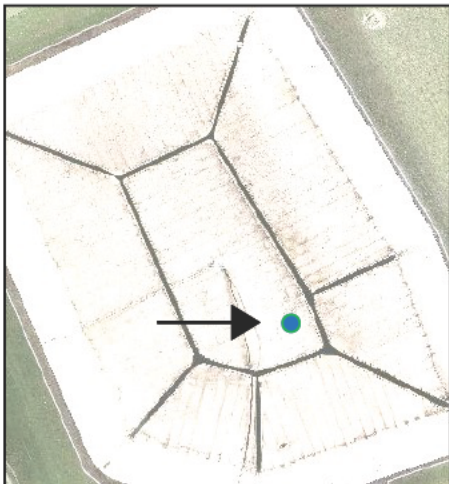
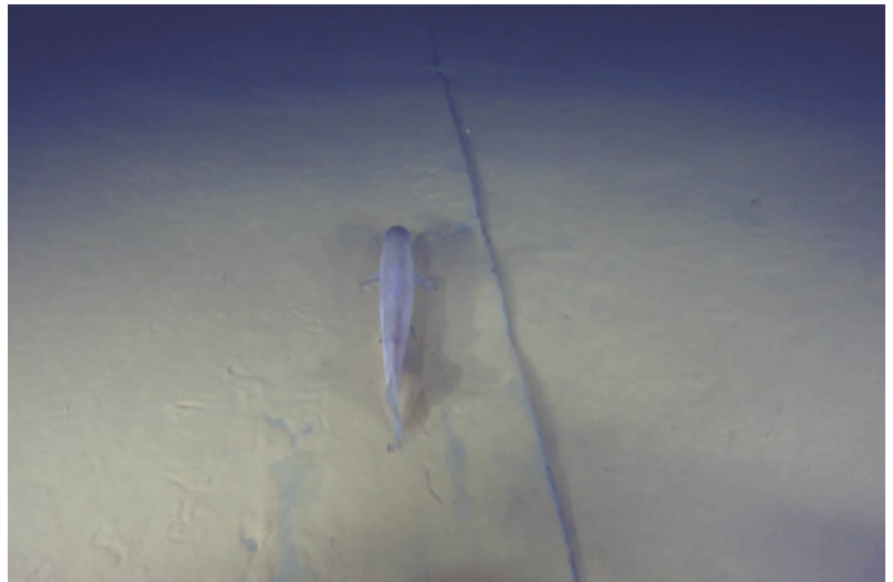
Marine Life Item 02

Area is on the reservoir floor.

Description: Fish, unknown species, observed. Approximate length 100mm - 120mm long.

Its possible the same fish was observed twice at two different locations and time. This could not be ruled out at the time of survey.

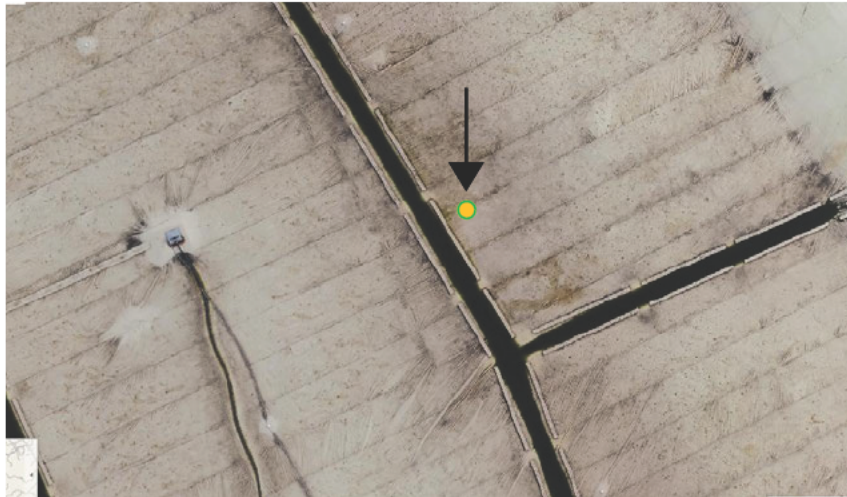
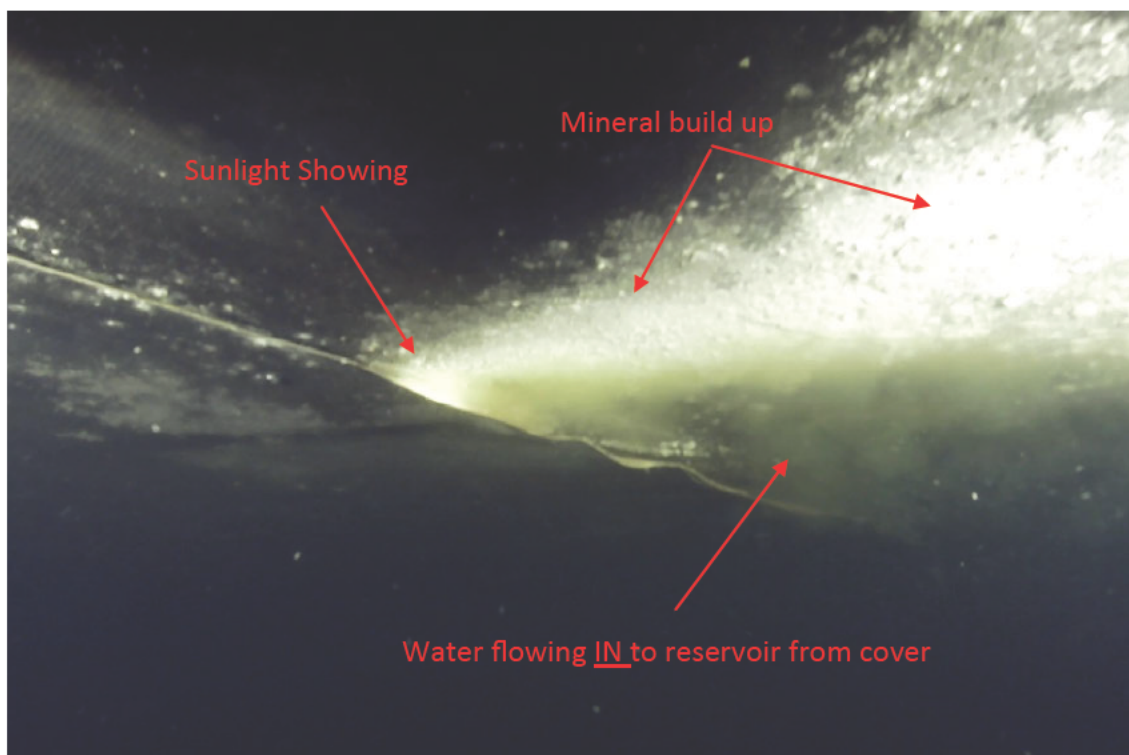
Anomaly 01 : Tear in Cover Seam

Stage 5: Reservoir cover trough inspection. Minor flow detected at one tear location only.

Description: Tear in Cover. The seam has parted at this location, water was clearly flowing IN to the reservoir from the cover. Tear appears to be approx. 100mm long

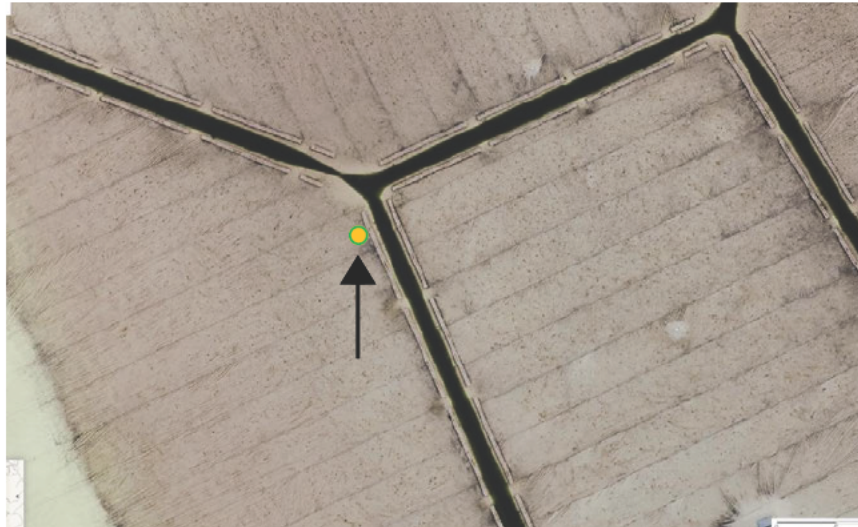
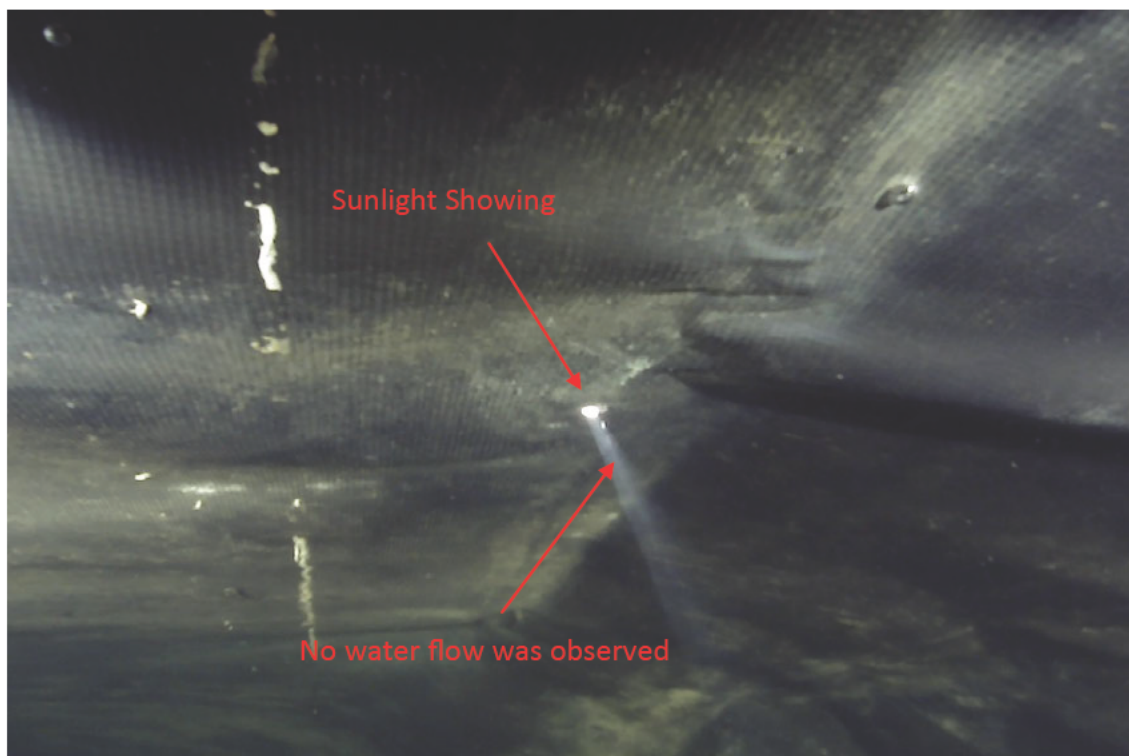
Anomaly 02 : Hole In Cover

Description: Hole in Cover. A hole was observed at this location. Approximately the size of a finger. No water flow was visually detected.
