From: Allie Dunn
Sent: Friday, 8 August 2025 4:58 pm
To: [REDACTED]
Subject: CM: Response to request for information re Dannevirke Impound Supply Reports
Attachments: bay dynamics report rov drone submersible - dannevirke impounded water supply laws rd ~ water survey report 24 august 2021 (002)(d22_14830).pdf

Laws Rd Reservoir In Water Survey

24 August 2021

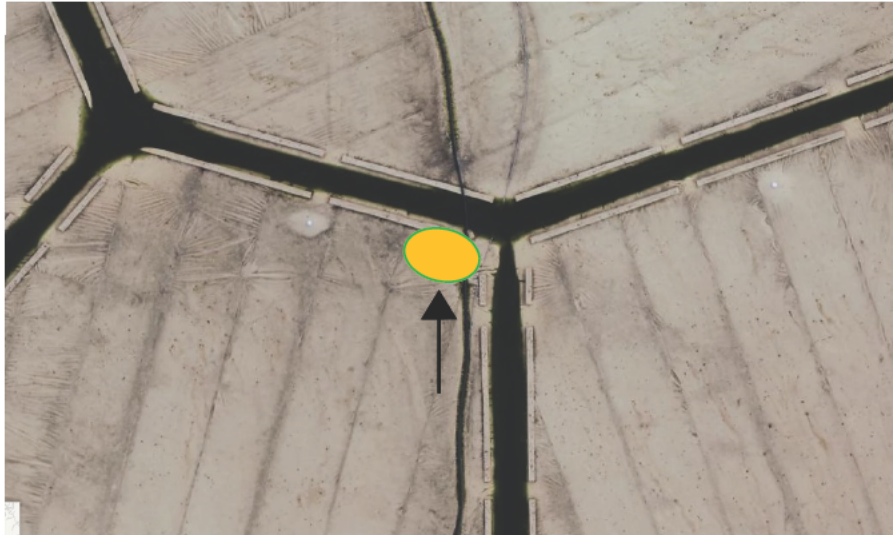
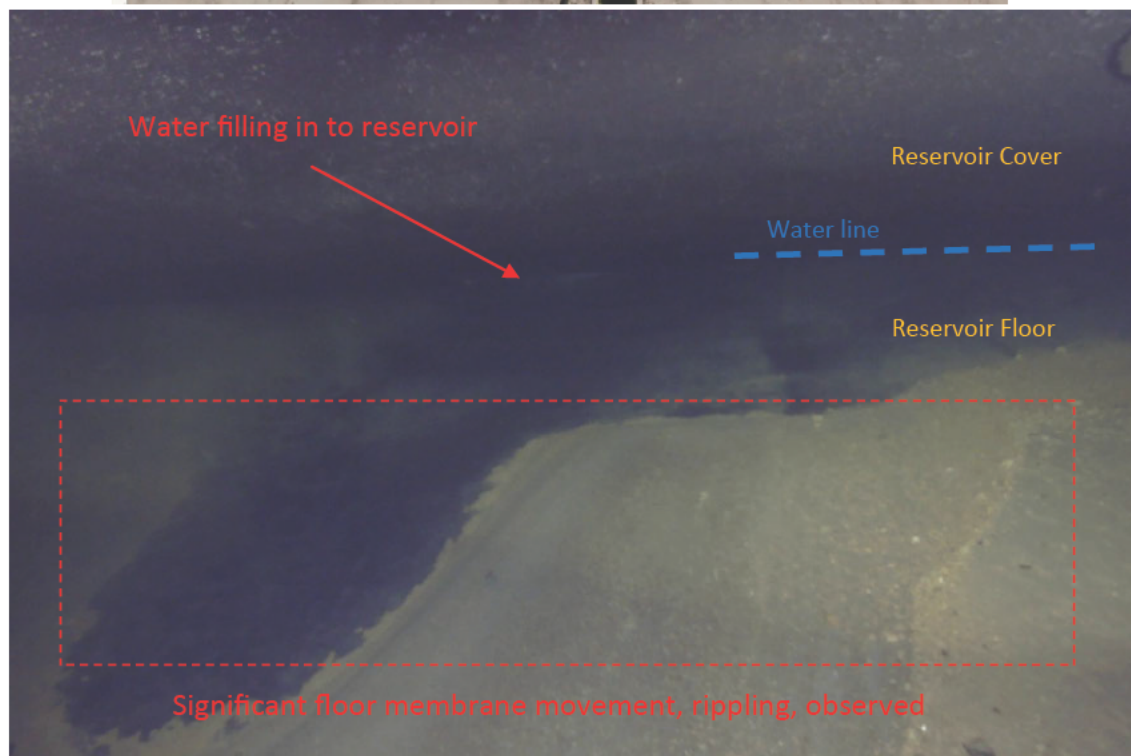
Anomaly 03 : Ripples in Floor Membrane

Description: Significant movement, rippling, was observed on the floor membrane. This is under the filling location. This is indicating that either air pockets or water flow is occurring under the floor membrane.
