Dannevirke Water Update

Public Meeting
27 June 2023

Impounded Supply Leaks

Temporary Repairs

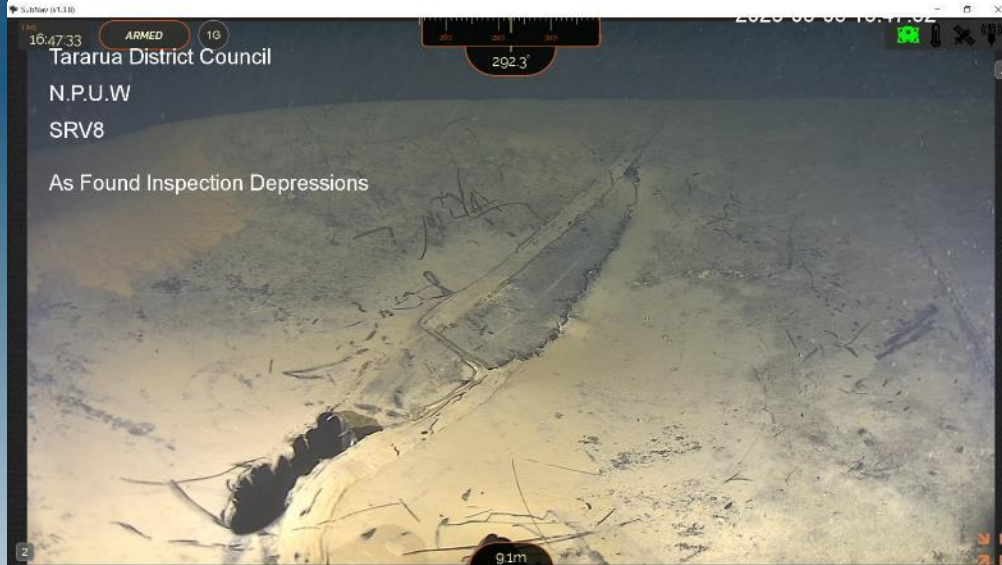
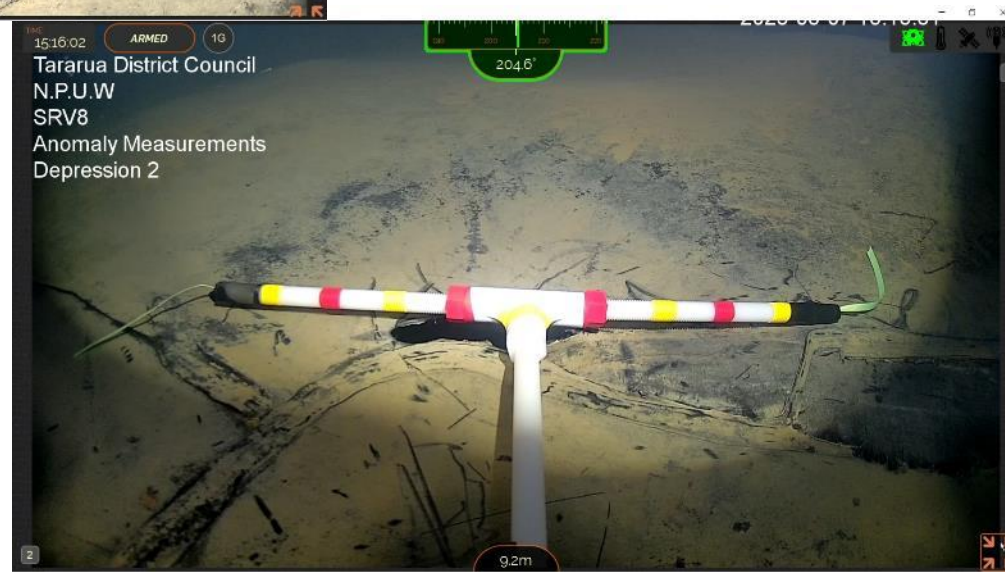
Tears identified 12-14 May 2023

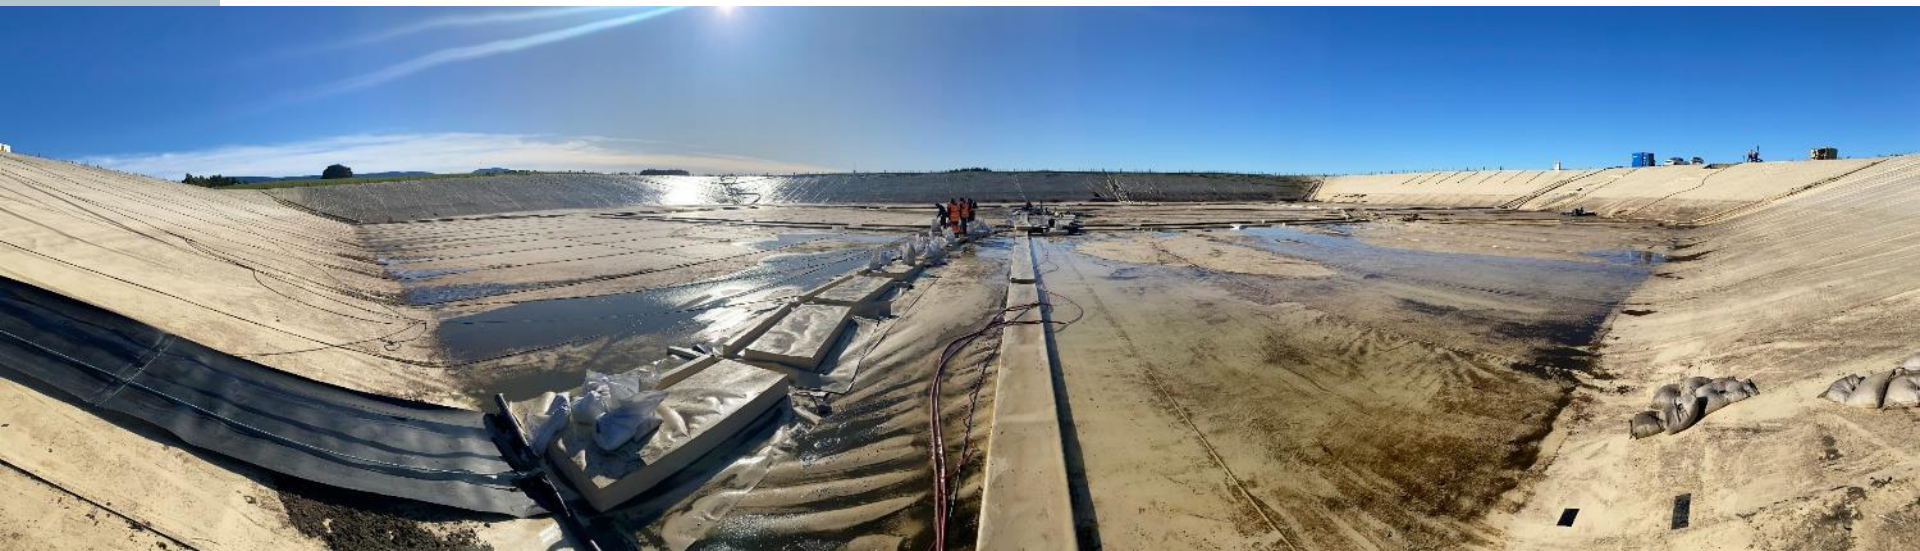
- Objective – to safely complete temporary repairs necessary to stabilise the impounded supply, reducing the risk of failure
 - Reduce measured leakage to less than 10 L/s
 - Enable permanent repairs to be completed 2024/25

Temporary repair operation 13-19 June 2023

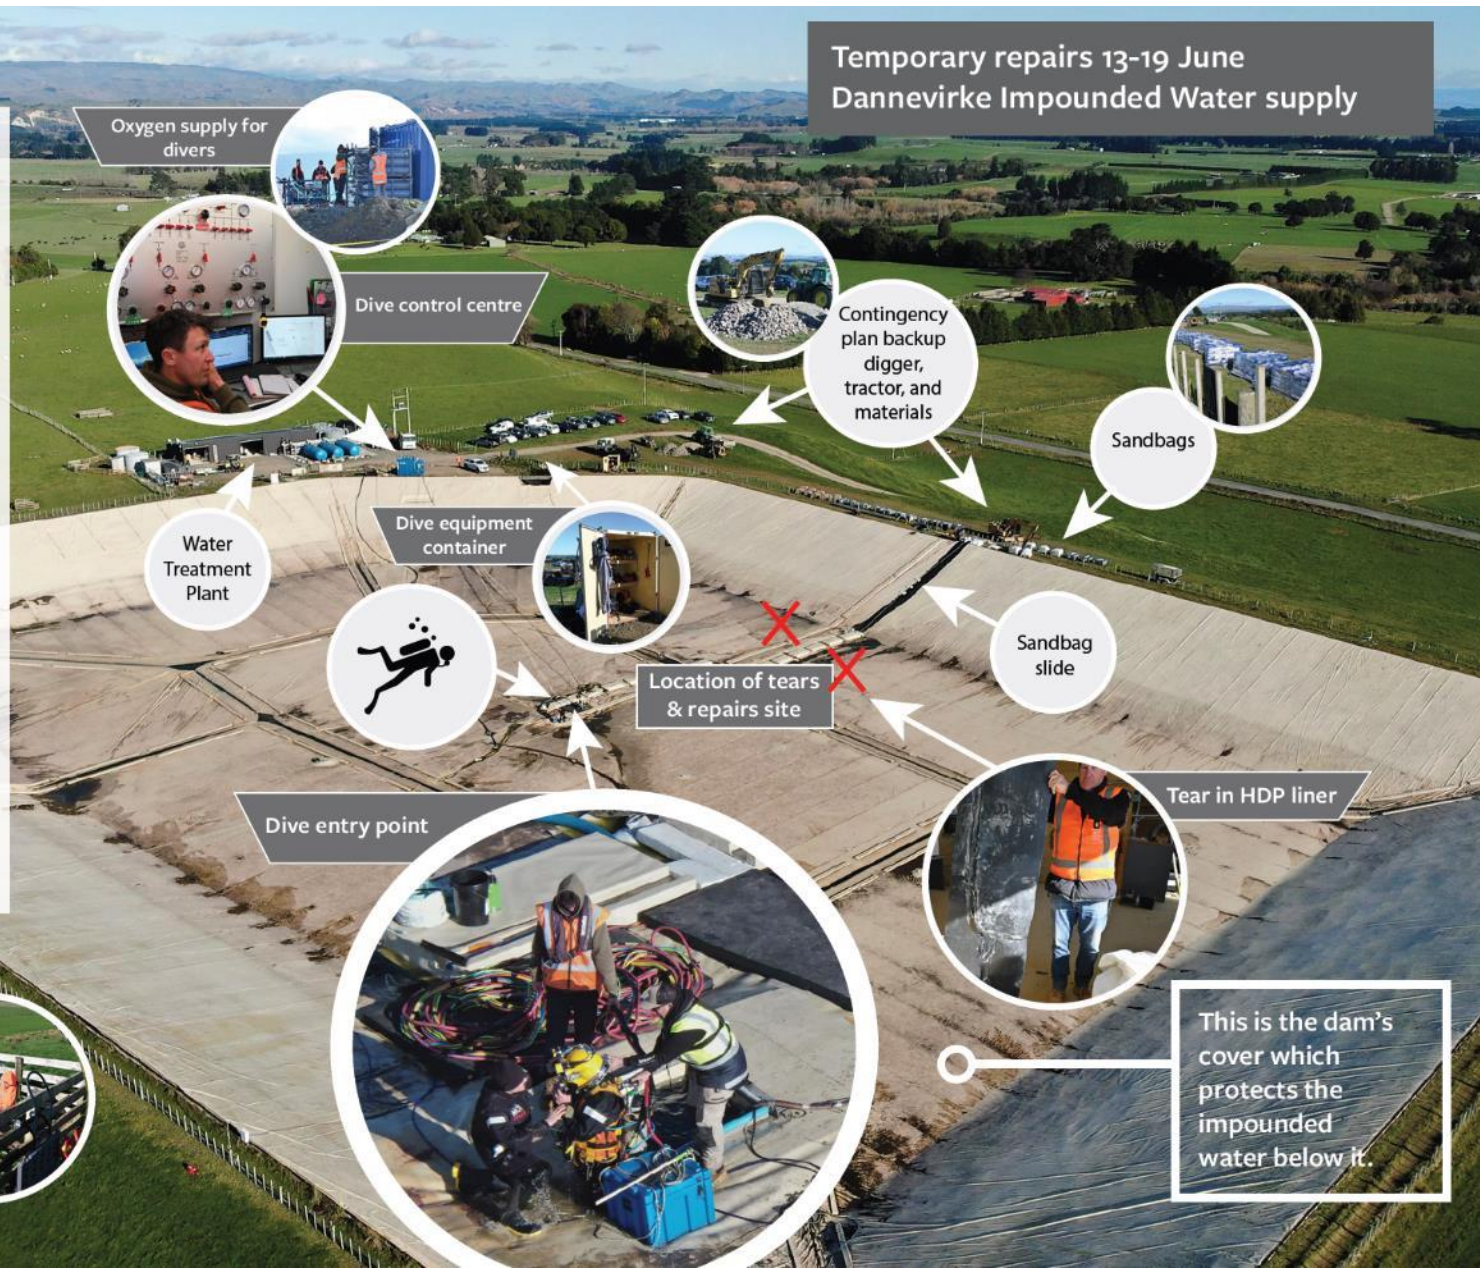
Temporary repairs 13-19 June
Dannevirke Impounded Water supply

The temporary repairs were carried out on the dam floor, around 6.5 mtrs below the water level.

The liner around the 2 tears was cut out and the cavity which had formed below was filled with sand, after which a specially designed patch was sealed onto the existing liner.

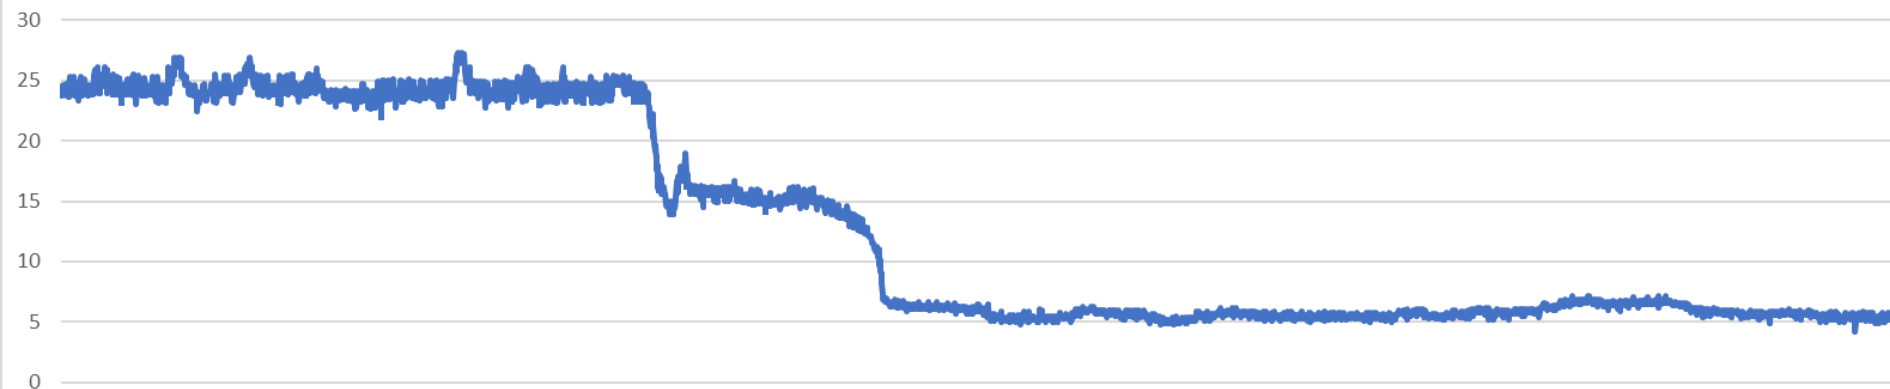
Impounded Supply Subsoil Drain Discharge Flow Rate (l/s)
10 June - 26 June 2023

- Slow but steady progress
- No deterioration of the eastern embankment (the dam wall) noted
- Subsoil drain outlet flow has reduced from ~25 litres per second to ~5 litres per second

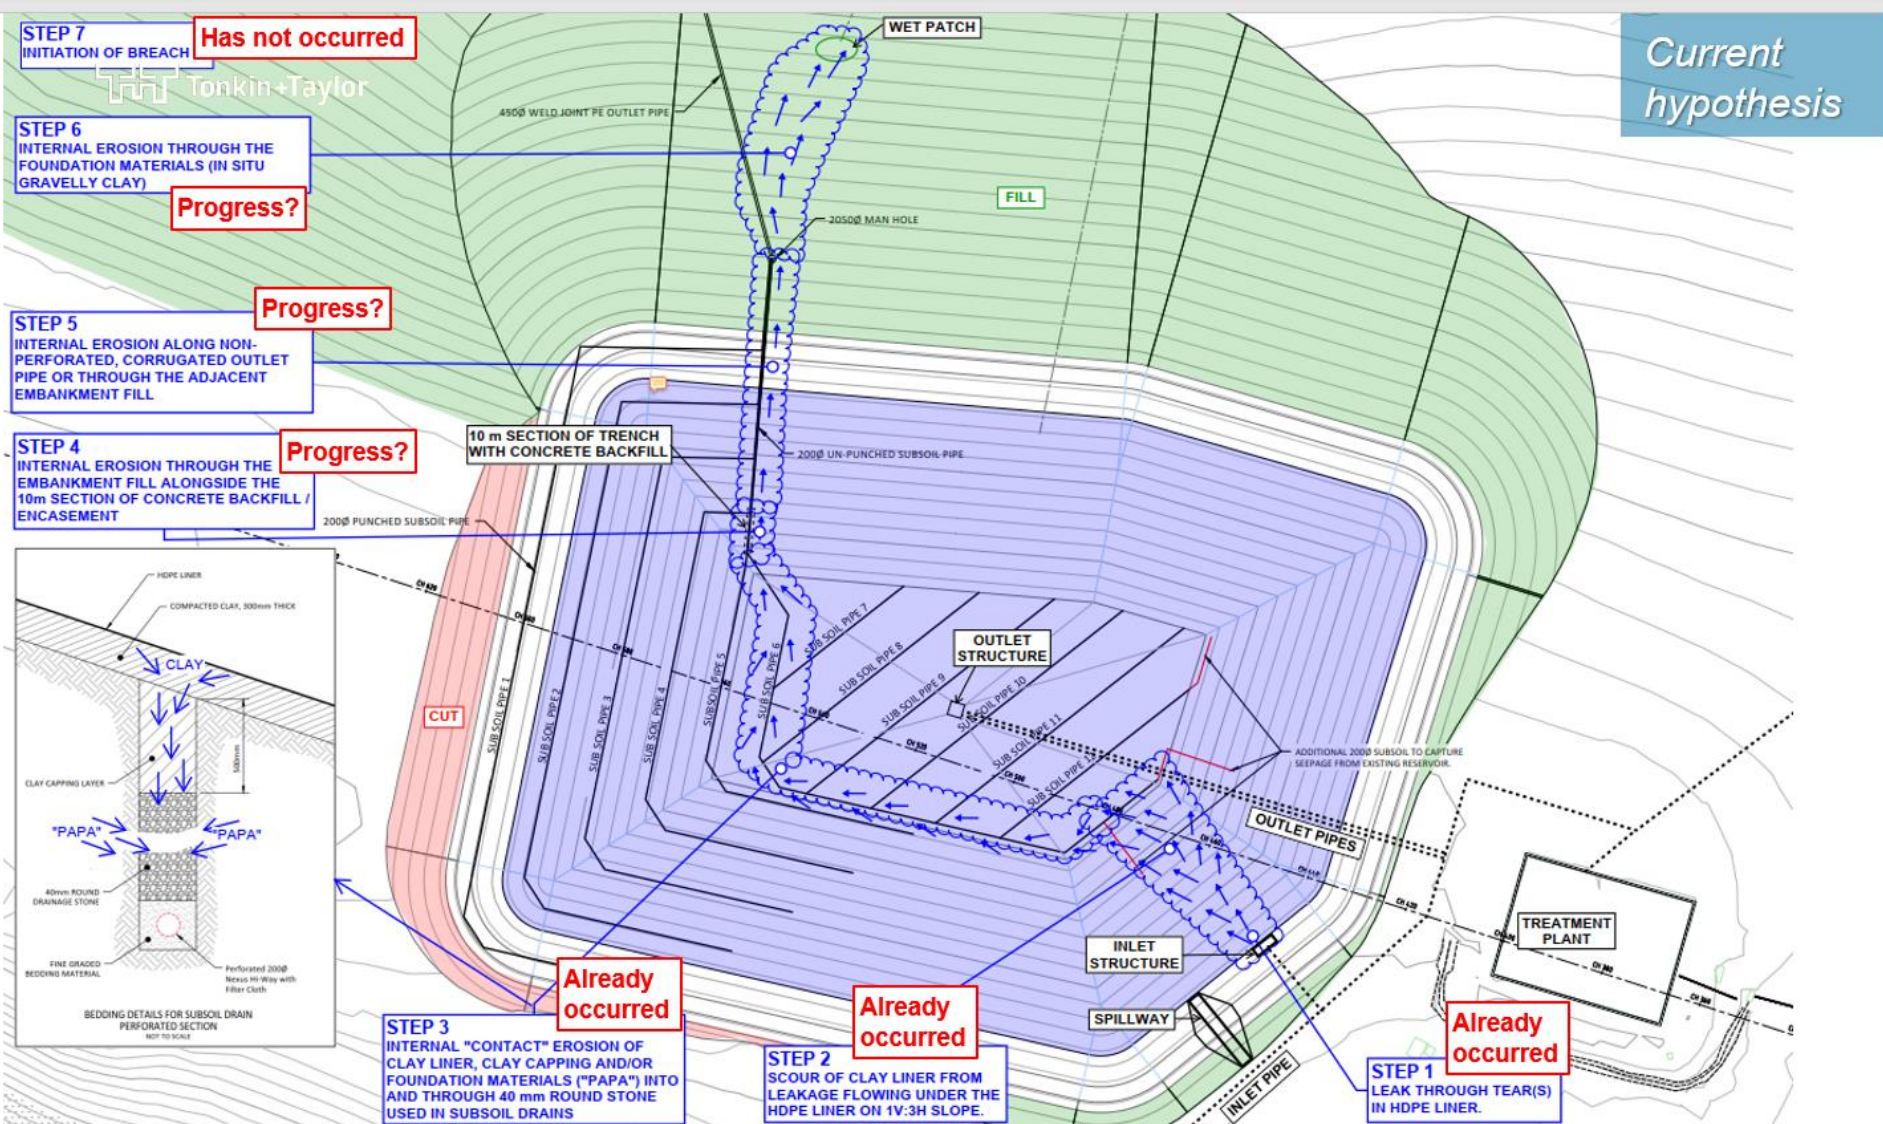
What is the issue?

- Condition of the liner is worse than expected
- High risk that more tears/leaks will form
- Regular assessment is required
 - ROV inspection within the next month
 - Subsequent ROV and/or diver inspection
- Almost certain that we cannot wait until 2024/25 summer to do permanent repairs which reduces the range of options:
