CLIENT REPORT
Tararua District Council
Laws Road Reservoir
Dive Inspection & Repair

Laws Road Reservoir – Dive Works – Remarking of Depressions and
Pinhole Repairs.

Authors: Natalie Menzies
Last Modified By: Natalie Menzies
Document Custodian: New Plymouth Underwater Ltd
Document Number: NPUW-RPT- TDC- 2407-09
Issue Number: 1
Date First Issued: 24 February 2025

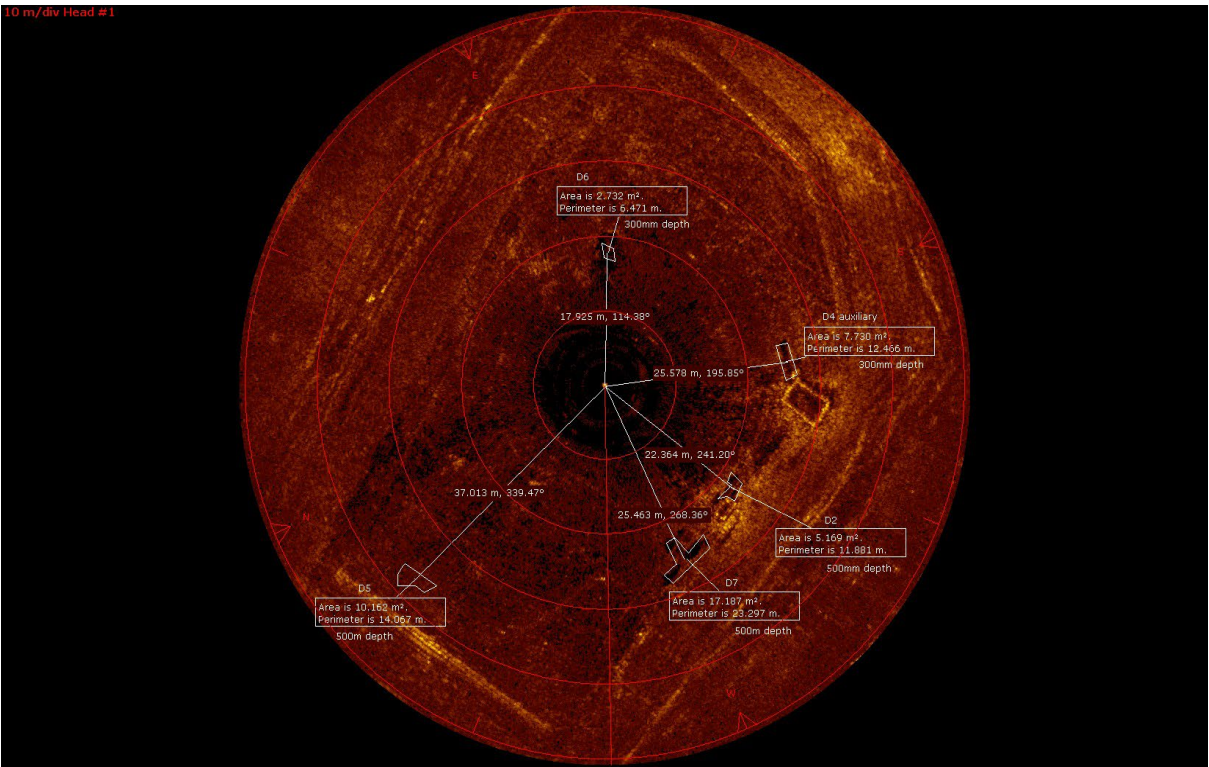
Depressions Sonar Capture noting Depression 7

Depression 7 had not been mapped previously by Divers. The location was supplied by ROV imagery (page 6) Depression 7 had three locations successfully mapped, with the West face unreachable due to the depression and batter-face interface.

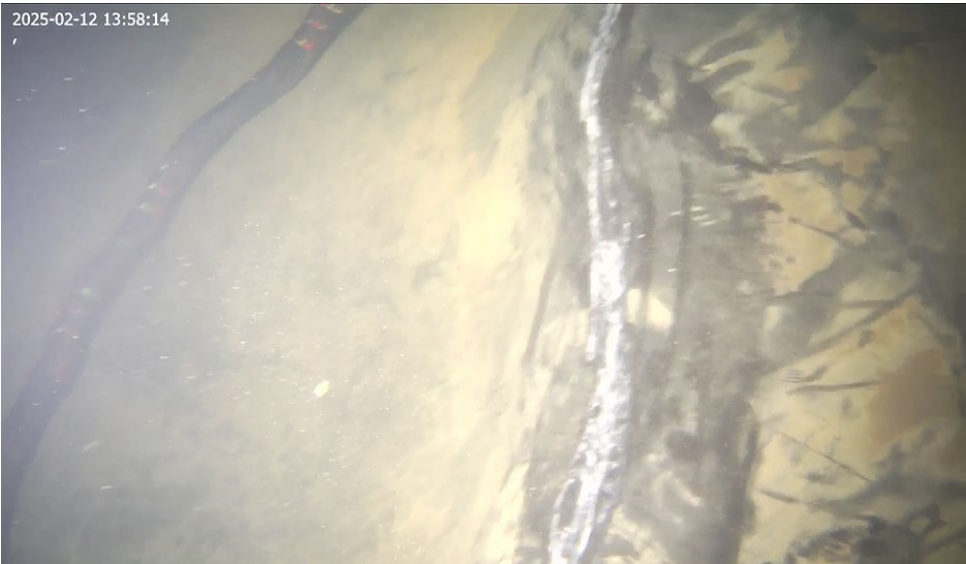
Divers observed the batter-face to have collapsed into the depression, causing a ridgeline approx. 2.7m from the North end running East to West. This is consistent with the previous survey in June 2023.

Depression 2 as found

Depression 2 was successfully remarked as per the brief.

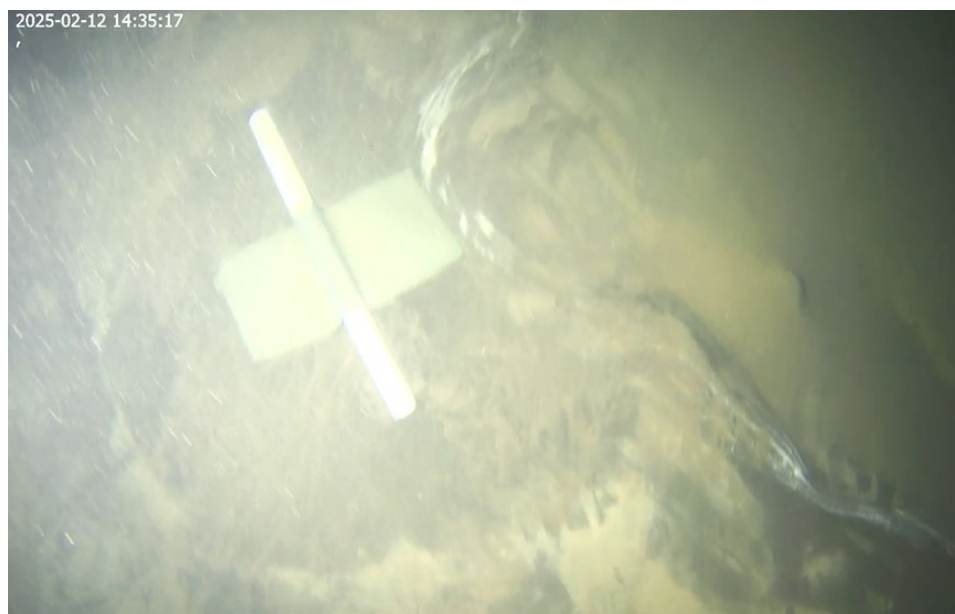
View of Depression 2 as left

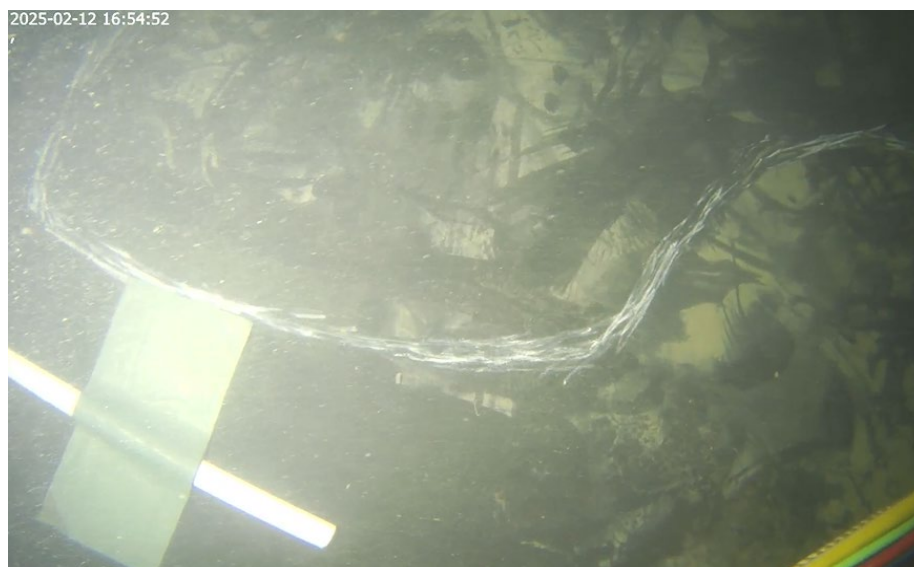
Two branching depressions were observed, one to the South West and one to South East, these were mapped and captured on video (shared media)

The approximate measurements of the newly formed South East Depression:

Length: 2050mm

Width: 600mm

Depression 4 South East corner as left snap shot

Depression 4 was successfully remarked as per the brief and the overall size appeared consistent with the previous survey.

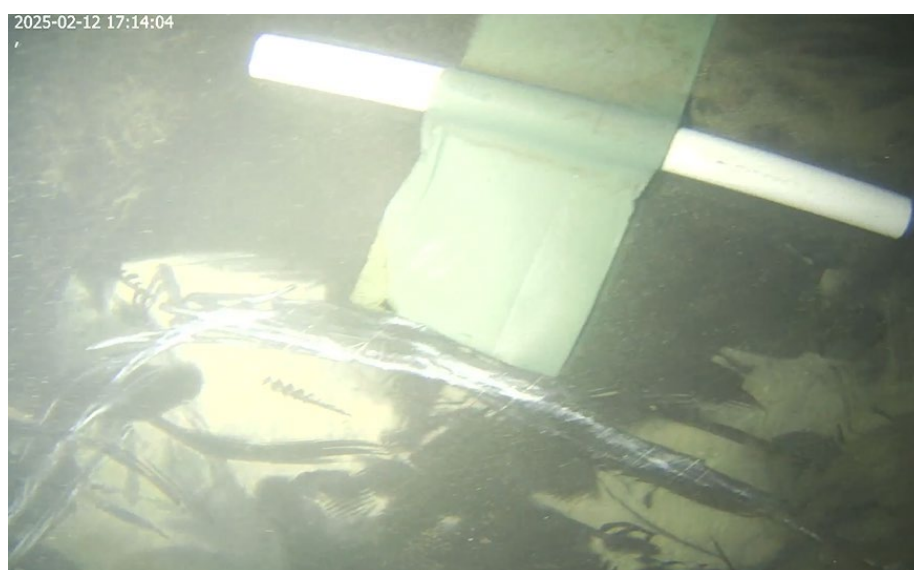
The approximate measurements of the newly formed South West Depression:

North width: 1000mm

South width: 700mm

South length: 2300mm

Depression 4 South West corner as left snap shot

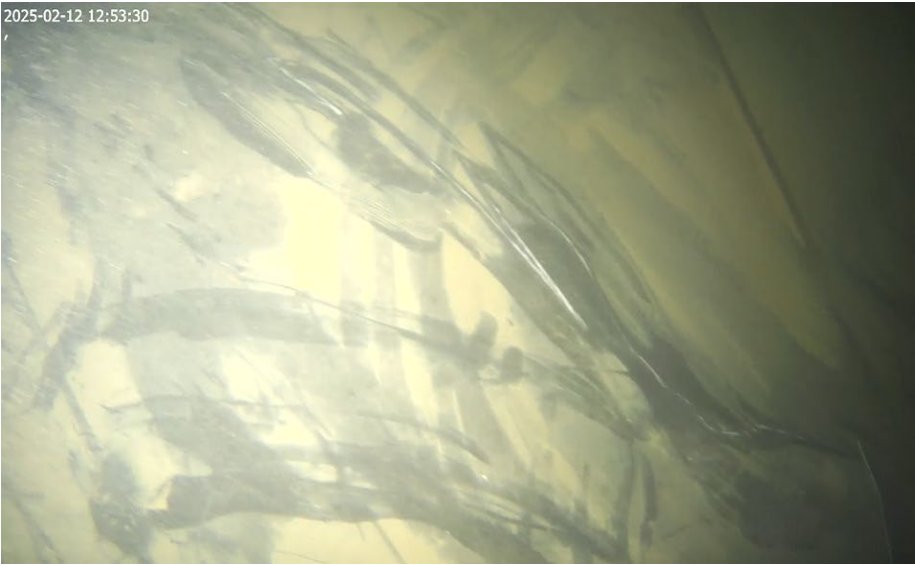
Divers detected multiple smaller depressions running towards the batter-face and west end. This measured between approx. 250mm – 100mm. This can be observed in video footage (shared media)

Depression 5 - as found

Depression 5 was successfully remarked as per the brief and was consistent with the previous survey. The perimeter was marked with Chalk and PVC piping. The cardinal marks – N.E.S.W were marked with chalk.

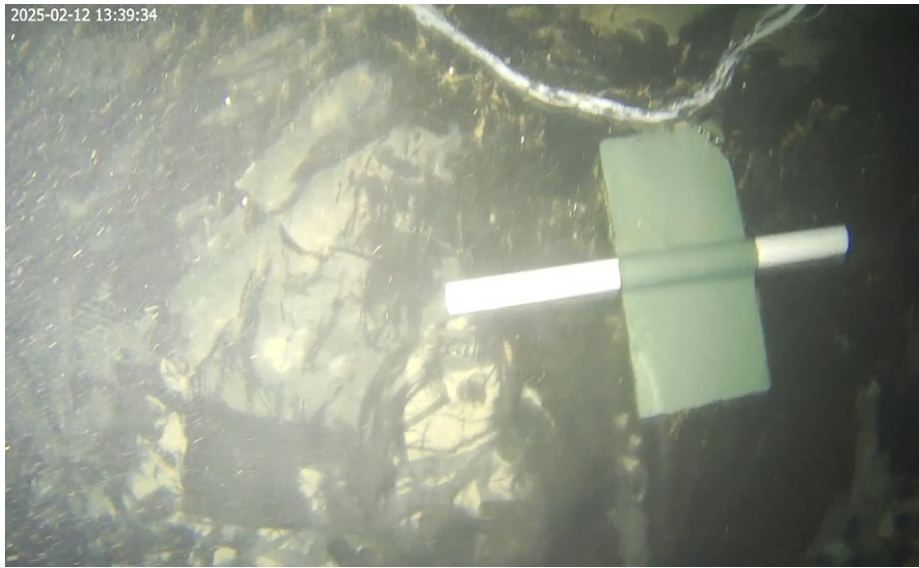
Depression 5 – as left with fresh chalk and PVC piping

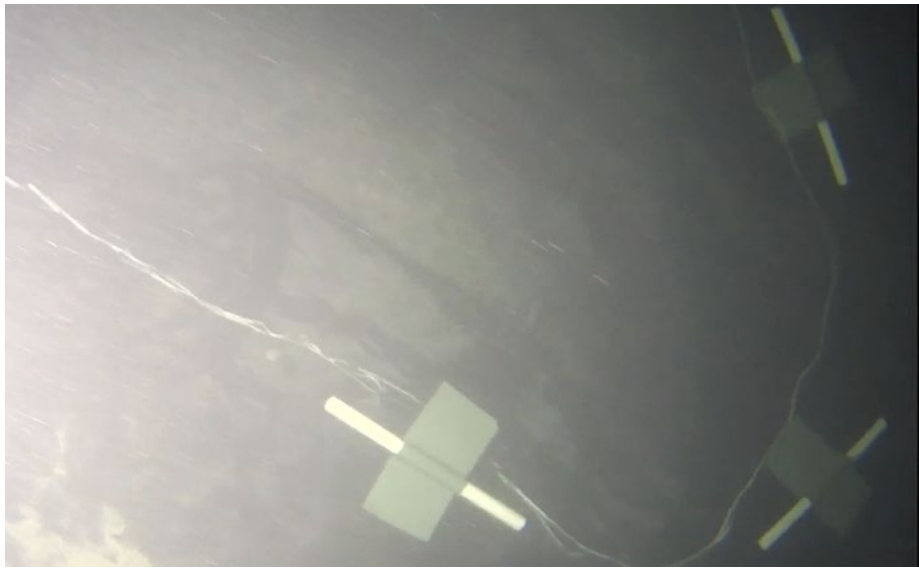
Depression 6 was the first depression to be located, being the first location, the water clarity was excellent and a more obvious depth and shape was noted. Depression 6 has more circular geometry than the other depressions and an approximate depth measurement could be taken.

Depression 6 – Eastern side curve and markings

Depression 6 was successfully remarked as per the brief and was consistent with the previous survey. The perimeter was marked with Chalk and PVC piping.

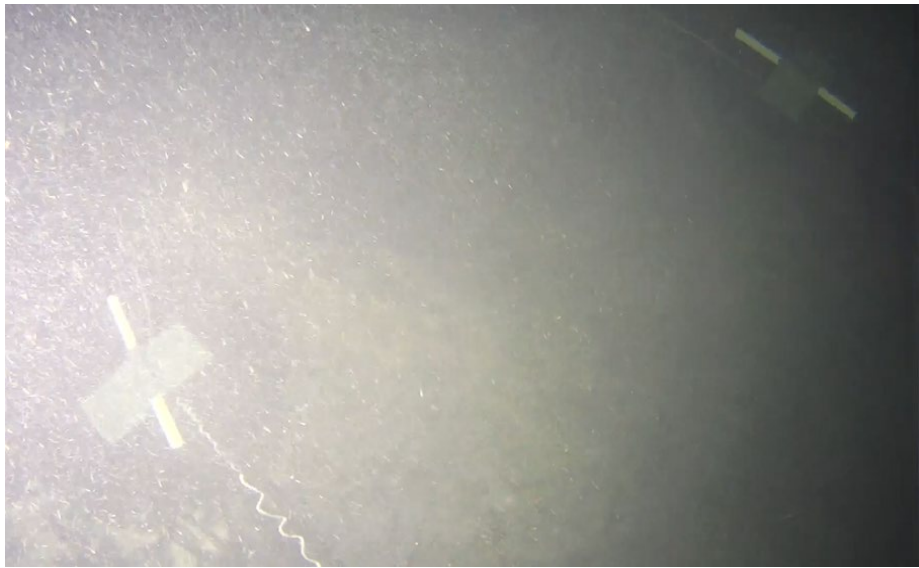
Depression 6 – Northern side markings

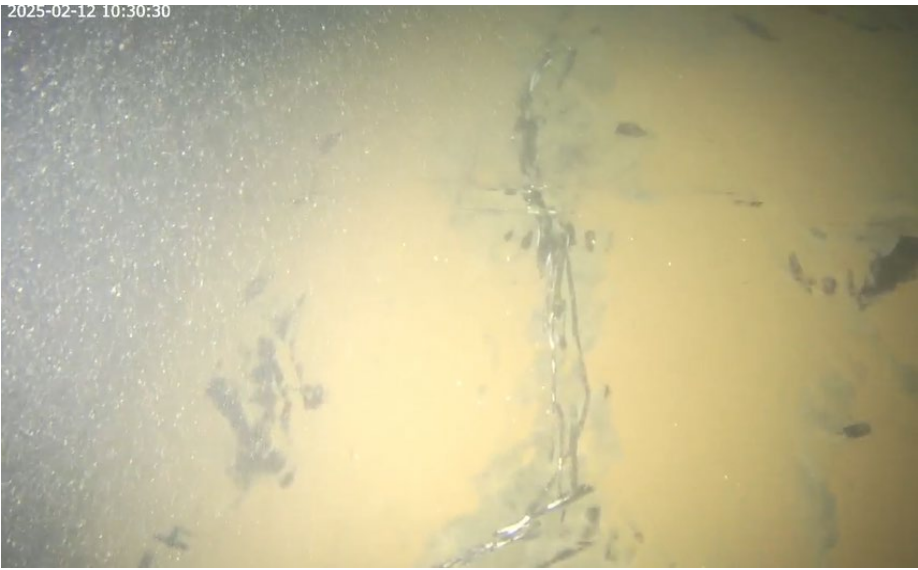
Depression 7, Western batter-face marked

The accessible areas of D7 were successfully marked with chalk and PVC piping.

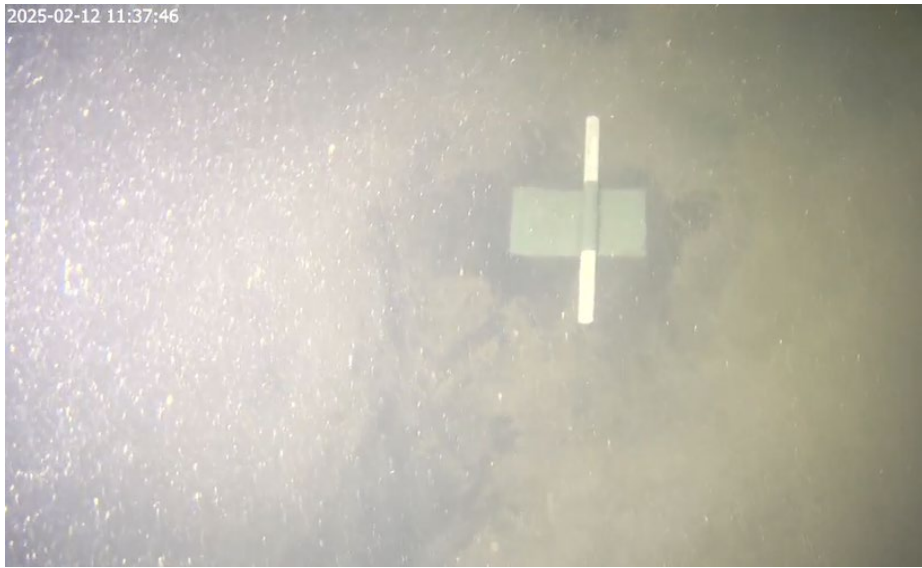
Depression 7 – Western batter-face marked with PVC piping

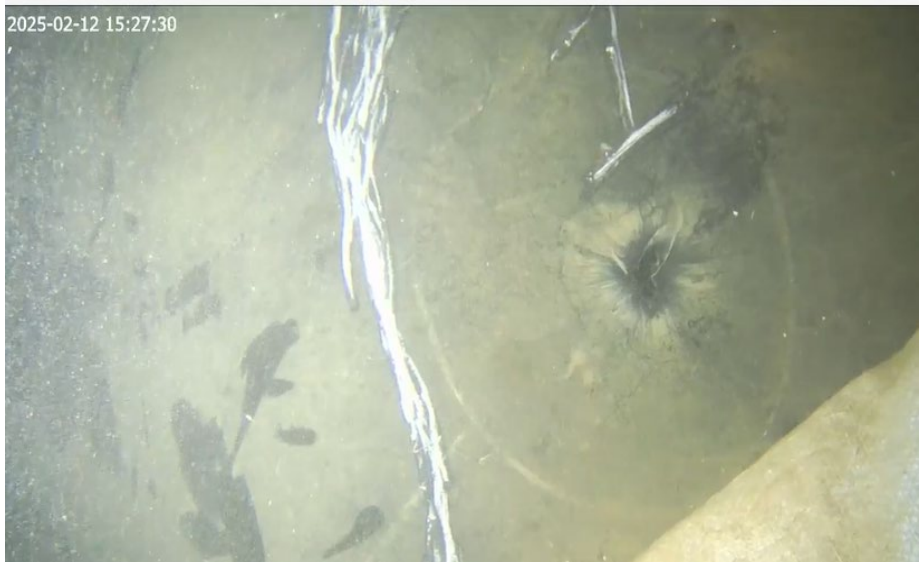
Pinhole 1 was located on the West side of D4, the pinhole was captured in as found video footage. The pinhole has been repaired and marked.

Depression 4 – Pinhole 1

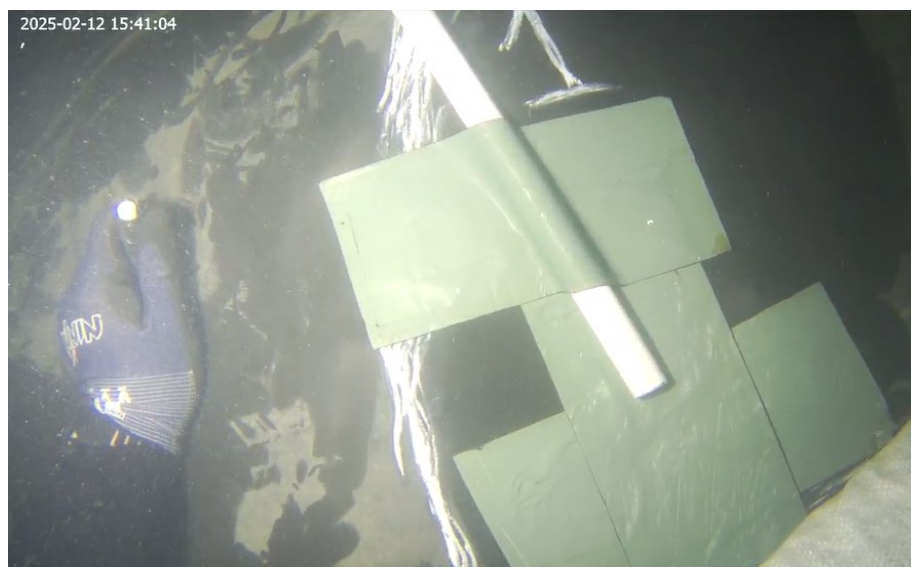
Depression 4 – Pinhole 1 repaired and marked

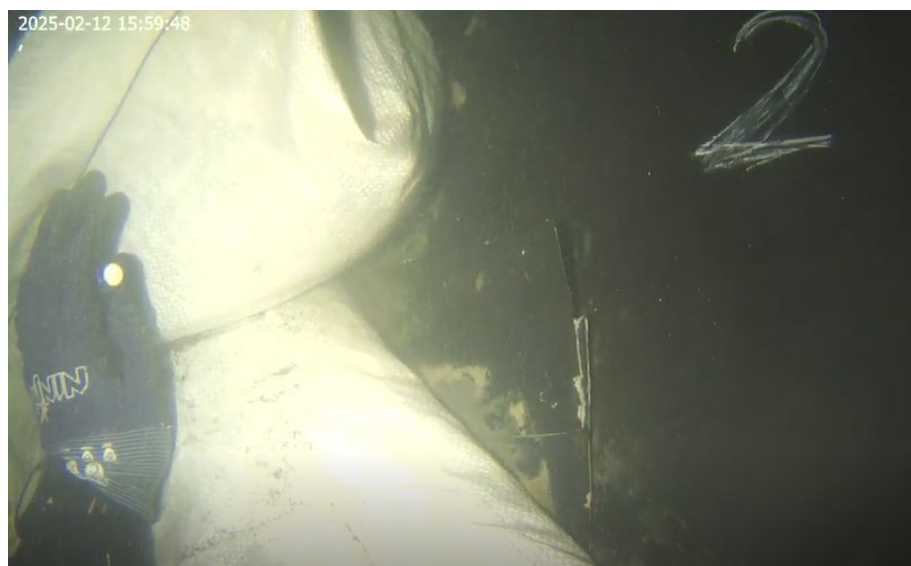
Pinhole 2 was located on the South West corner with the previous repair tape lifting. The pinhole has been repaired and marked.

Depression 4 – Pinhole 2 as found.

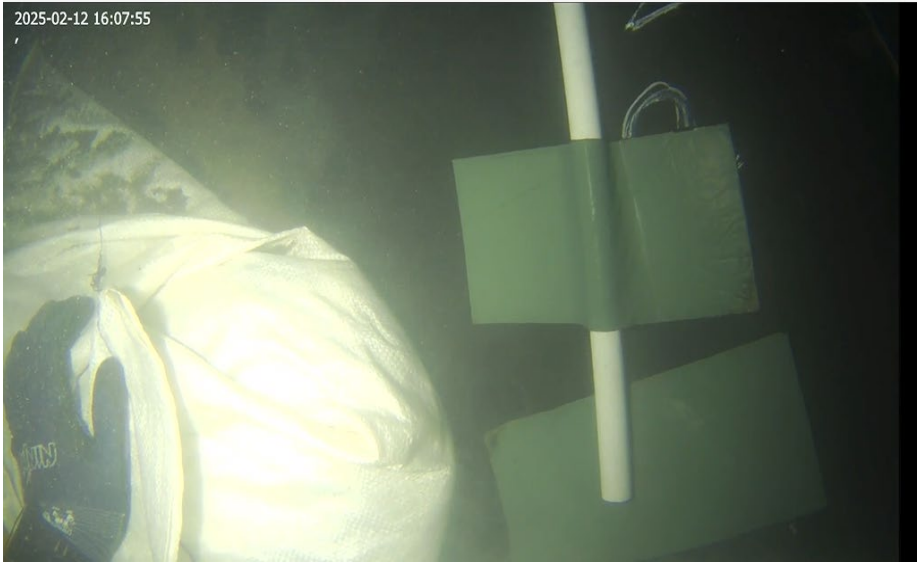
Depression 4 – Pinhole 2 repaired and marked.

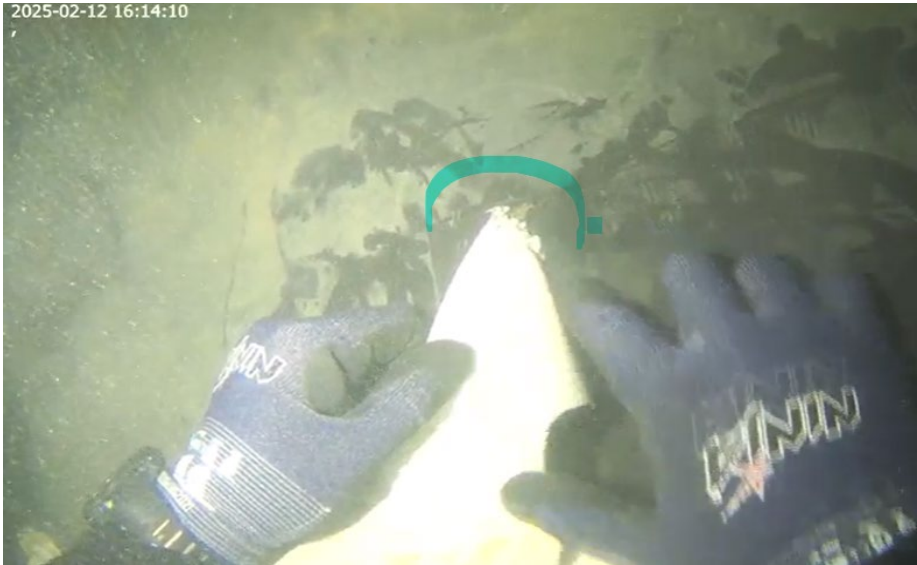
Pinhole 3 was located on the North West corner and repaired. The Pinhole was captured in as found video footage. Pinhole was repaired and marked.

Depression 4 – Pinhole 3

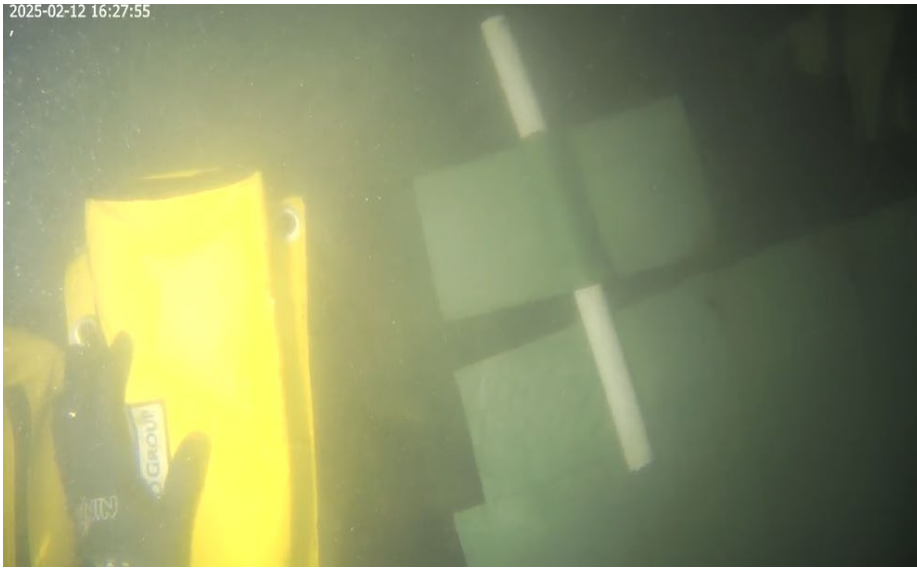
Depression 4 – Pinhole 3 repaired and marked
