Subject: Response to request for information re Huxley Street Drain Pahiatua

Date: 12th April 2024 Tararua Alliance c/ Eddie Charlton – Utilities Manager

Storm Drain Maintenance Report

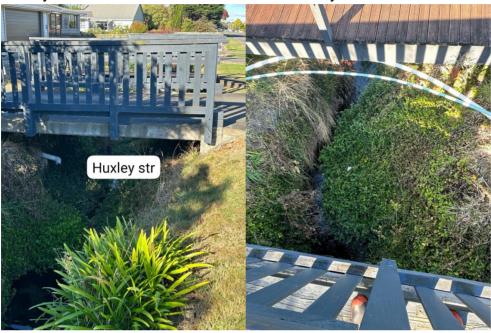
Huxley St/ Princess St

- Titoki Street has a deep drain that is well maintained.
- Paterson Street is tidy and only required minor clearing.
- Huxley Road cleared of organic matter in center of drain.
- Halls Rd and Churchill Street drain has good water flow.
- Arthur Street has been cleared of organic matter in centre of drain.
- Duke St has been well maintained and will only require spraying in some areas.

Huxley – Queen st end

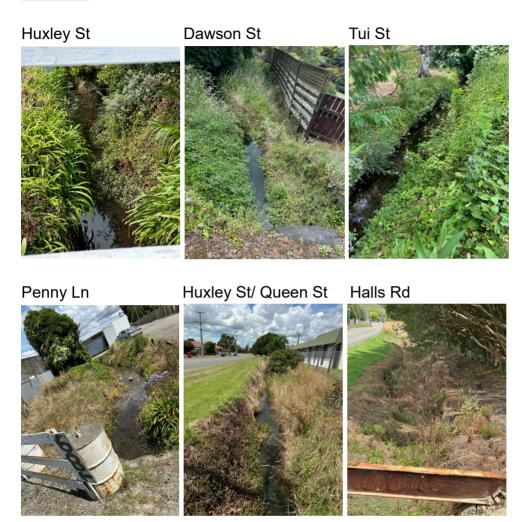
Pahiatua:

- Titoki Street has a deep drain that is well maintained and appears to have been sprayed,
- Paterson Street is tidy and has no requirement for spray. There are also ducks nesting in this area,
- Huxley Road cleared of organic matter and has been sprayed. There are gardens along some of the verges and did not require spraying,

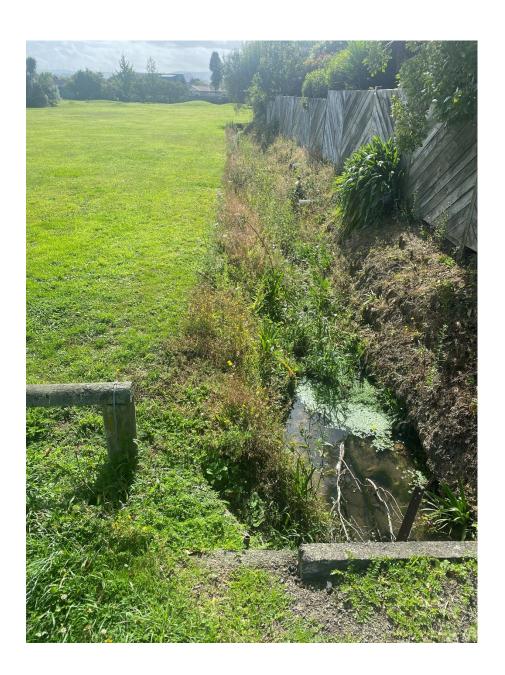
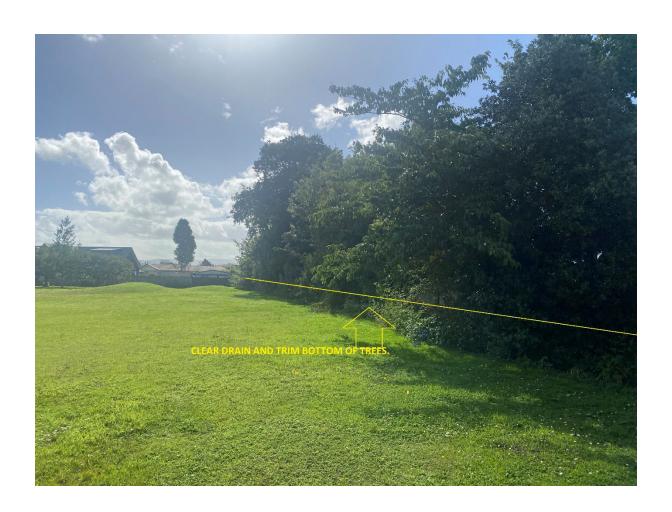
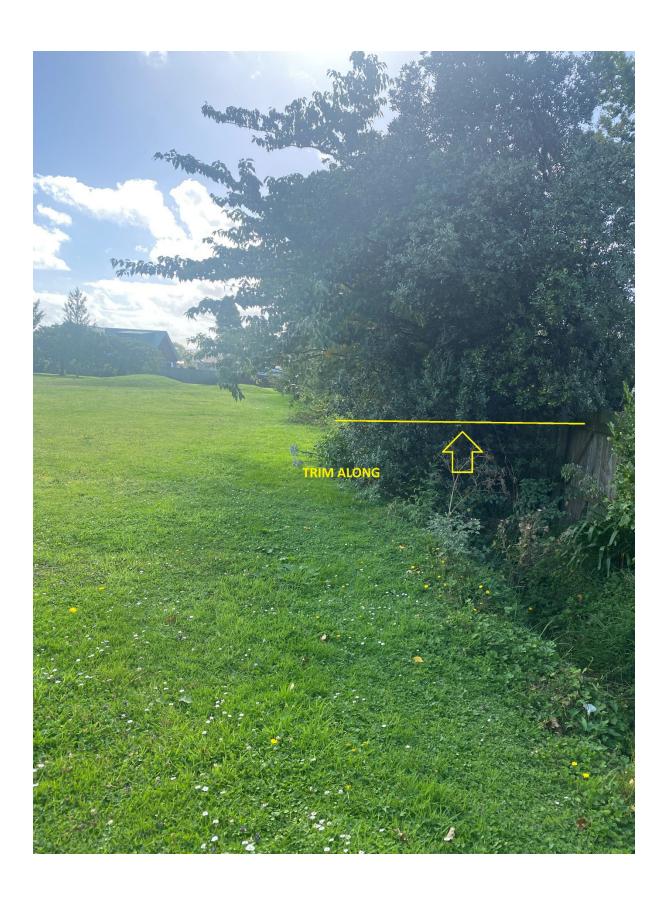
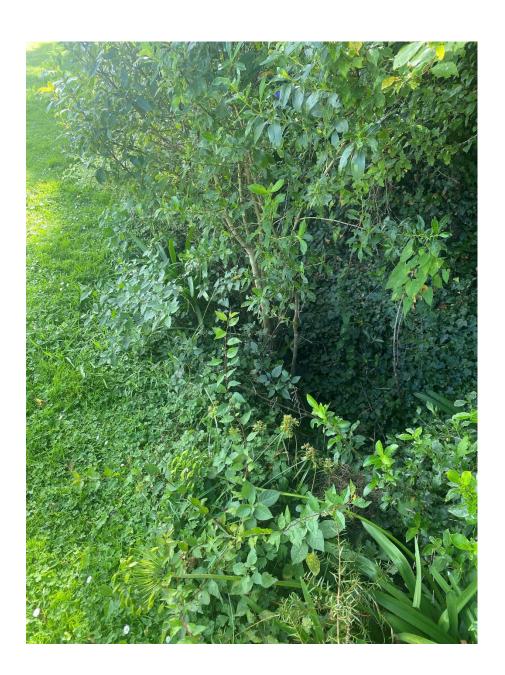
We are just wanting a general tidy up in the drain and light trim with the overhanging trees.

This drain runs along the back of houses approximately 140 meters.

This drain starts at Laws Rd and goes through Rotary Park to Huxley Street drain.
