In today's Tararua District Cyclone Recovery advertisement

Geological ground assessments on Ormondville - Te Uri road

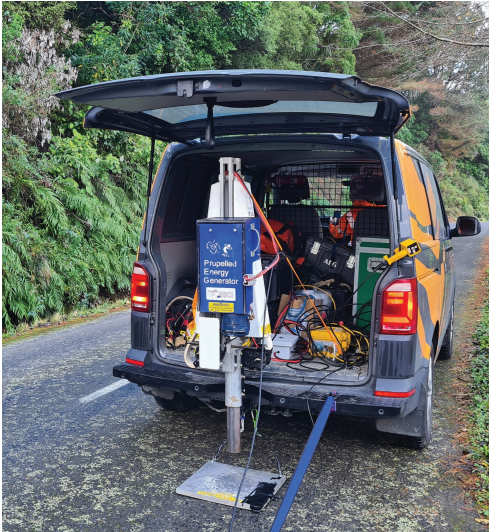
Anyone out and about on the Ormondville-Te Uri road recently would have wondered what they were looking at. As part of our geological ground assessments, a string of microphones are dragged along and a large weight/hammer dropped on to the road, this sends sound waves through the ground beneath to provide an understanding of the underlying ground density.

undertake earthworks and cut into it. "This is a technique I don't think we've ever used in the Tararua District before – the way the different colours depict different ground density is pretty cool!"

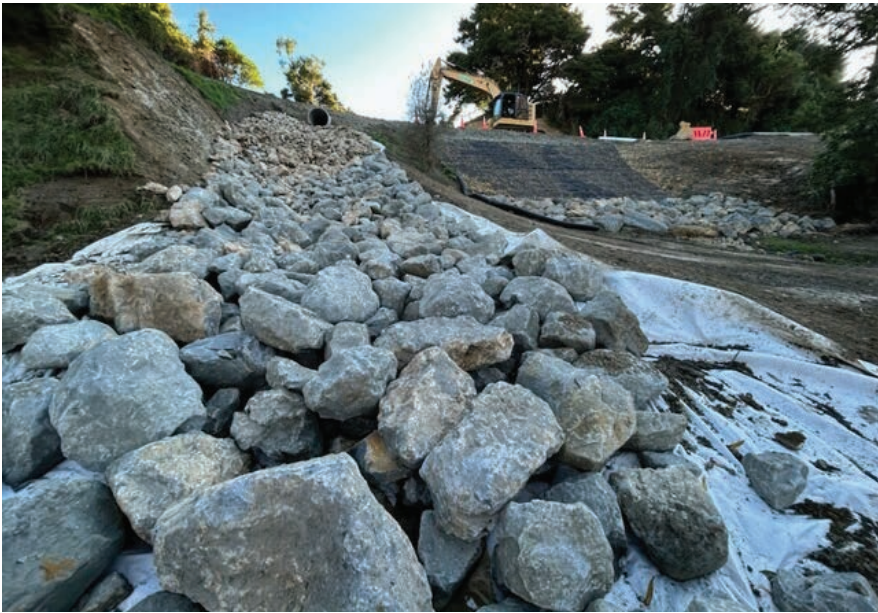
Coast Road – 2.2km from Pongaroa

**Job:** Culvert outlet repair and outlet stabilisation  
**What's going on?** Flows from existing culvert had scoured the outlet on the downslope to the adjacent stream. The culvert has been relocated and enlarged to accommodate increased flows expected due to the increasing severity of weather events. Rock rip-rap outlet protection has been used and the dropout repaired with a "terramesh" wall.  
**Outcome:** The road has been reinstated to full width, with surfacing scheduled for spring.

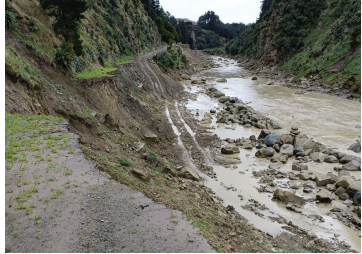
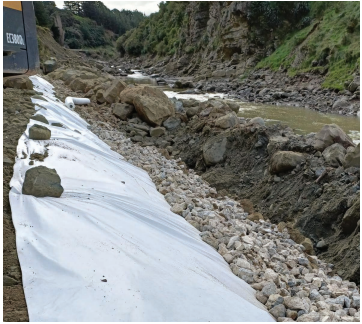
Marainanga Gorge update

**Job:** Work is progressing to provide temporary access along Coast Road at the Marainanga Gorge.  
**What's going on:** Rock rip-rap (uniformly graded large rocks) has been recovered from the riverbed and laid along the southwest embankment where the original downslope "toe" of the old road formation used to be. The existing remaining road has been benched down and compacted as fill material. At the southern end, the road has been lowered and moved into the gorge as additional fill.

Higher quality material has been imported to construct the foundation to create a more resilient road that is less likely to erode during high flows. To provide additional protection, a layer of geo-fabric is being placed along the face of the fill, then lined with small rip-rap, before the large recovered rock rip-rap is placed over this. Work crews will return to complete the final pavement construction. We anticipate that the final road height will be lower than the previous road, but wider. A lower road may result in water occasionally overtopping the embankment.  
**Outcome:** Once access is restored, the Tararua Alliance is planning to place the works on hold to seek funding and allow more detailed engineering considerations to be made.
