Dannevirke Water Supply Reservoir

Preliminary dam safety advice on abnormal seepage

Prepared for
Taranaki District Council

Prepared by
Tonkin & Taylor Ltd

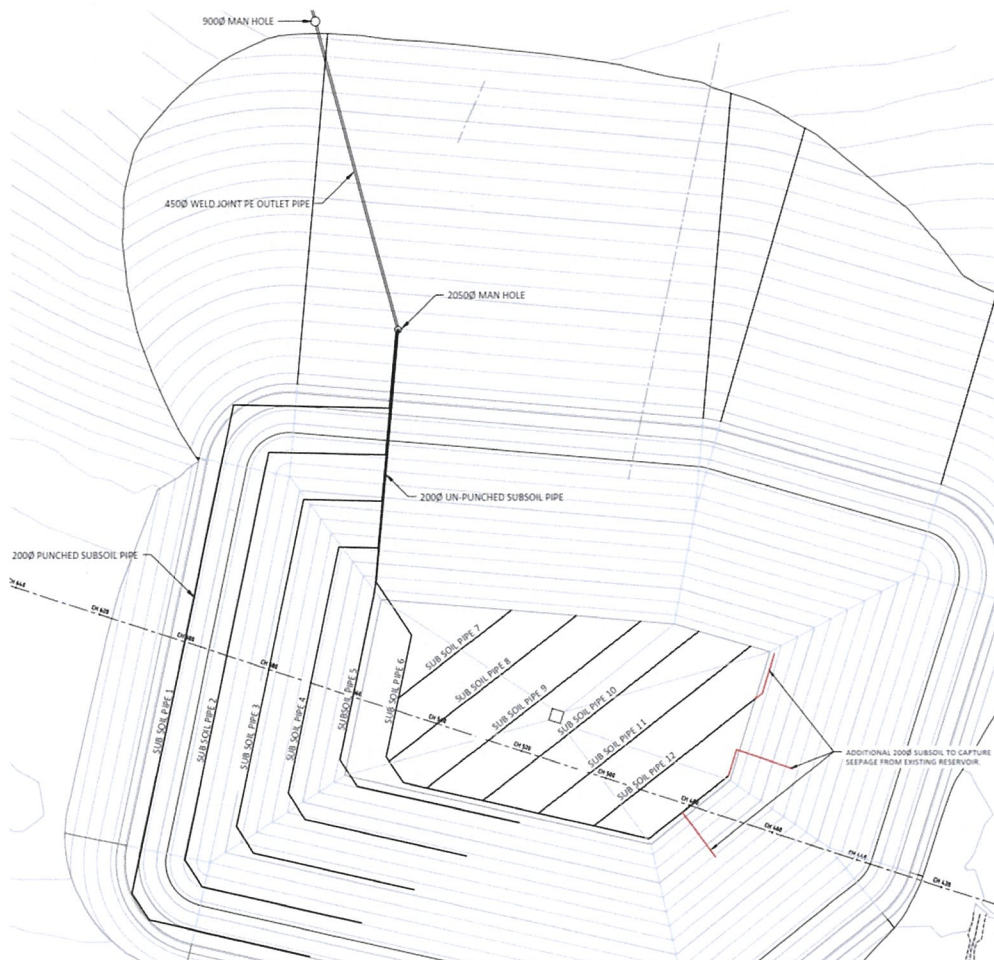
Figure 2.2: Subsoil drainage network underlying HDPE and clay liner

- The monitoring point for the measured flows is at the downstream end of the subsoil drainage pipeline at the outlet to the stream. A weir has been installed inside the 900 mm diameter manhole located on the subsoil drainage pipeline (refer Figure 2.2 for location), upstream of the monitoring point.

- Five separate discharge points at different elevations in the 2050 mm diameter manhole (refer Figure 2.2 for location) provide opportunity to monitor flows from different parts of the subsoil drainage network independently. This information could be used to identify the location and spatial extent of liner damage and leakage. TDC believe that seepage is emerging solely from the lowest discharge point, which we recommend verifying across the range of relevant conditions. If seepage is emerging from more than one discharge point in the 2050 mm diameter manhole, these flows should be monitored individually.

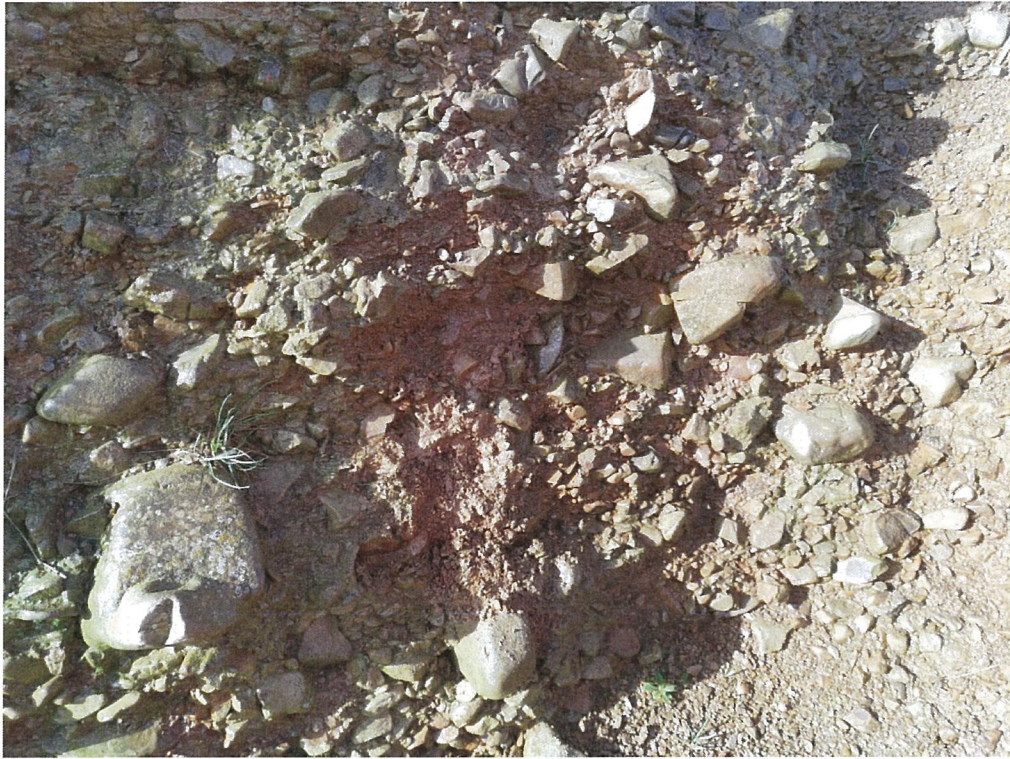
Figure A 8: Natural materials (silty gravel) exposed in cut alongside access track to reservoir
