From: Allie Dunn
Sent: Friday, 8 August 2025 4:58 pm
To: [REDACTED]
Subject: CM: Response to request for information re Dannevirke Impound Supply Reports
Attachments: bay dynamics report rov drone submersible - dannevirke impounded water supply laws rd ~ water survey report 24 august 2021 (002)(d22_14830).pdf

Laws Rd Reservoir In Water Survey

24 August 2021

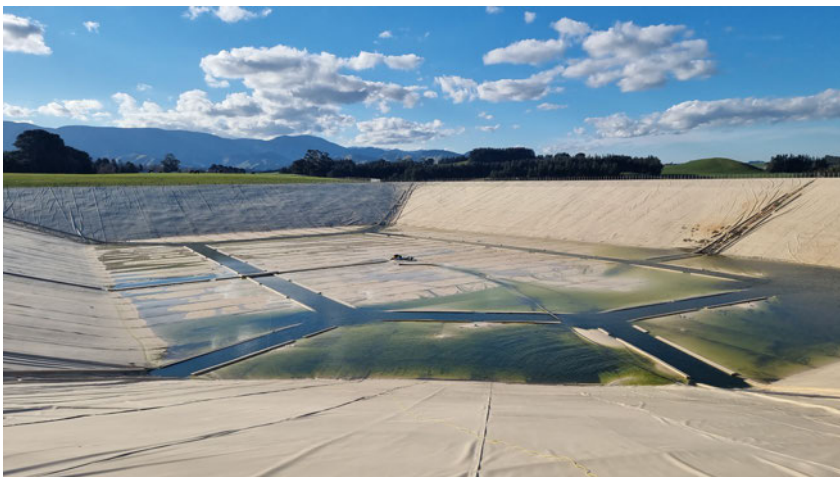
Reservoir as observed at time of survey.

During the survey the water depth ranged from 4.5m to 4.3m. In some places of the reservoir the water depth was measured as low as 3.9m, due to variances in the floor level.
