Subject: Response to request for information re Huxley Street Drain Pahiatua

Date: 12th April 2024 Tararua Alliance c/ Eddie Charlton – Utilities Manager

Storm Drain Maintenance Report

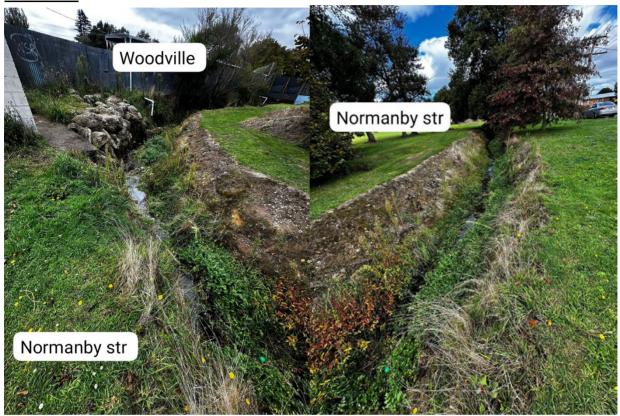
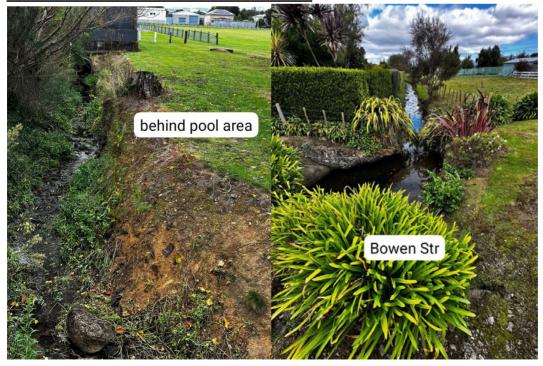
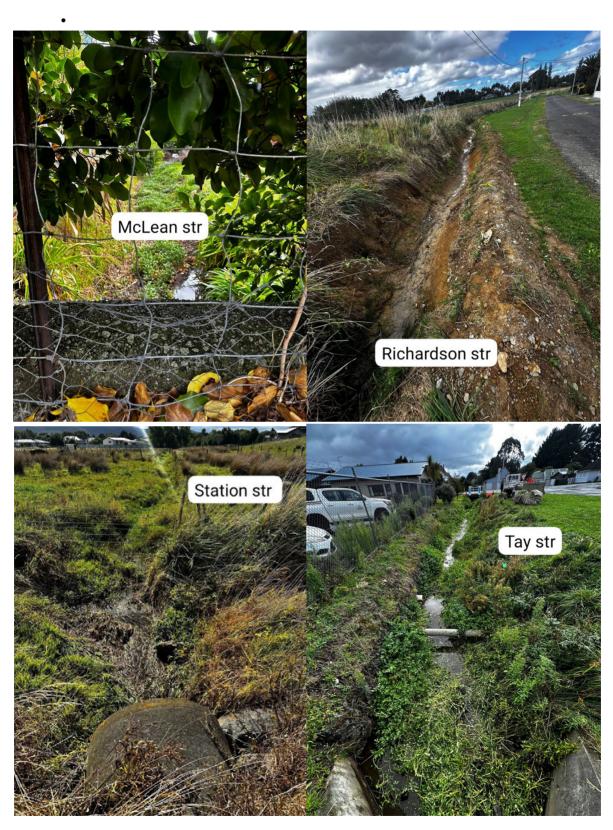
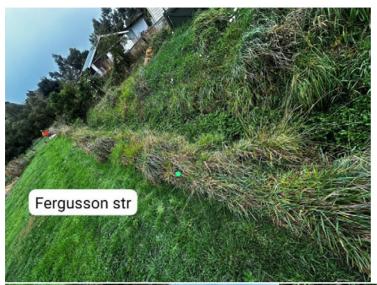
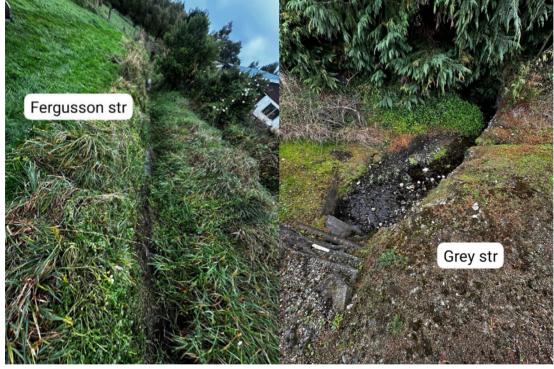
Woodville:

- Tay St has had clearing of heavy organic matter to allow waterflow.
- Burgoyns Street has stock on privately owned property and a new fence installed along the drain,
- Richardson Street is clear of organic matter.
- Sowry Street is completely dry and appears to have been sprayed.
- Ferguson Street is still inaccessible due to private property and stock,
- Normanby Street drain has been cleared of organic matter in middle of drain to gain waterflow.
- Pollen Street cleared of the organic matter prior to spraying, and
- Grey Street has waterflow around culvert but couldn't get access onto paddock but appears to be sprayed by owner.
- Mclean St (north) owner refused clearing inside property.
