Dannevirke Water Update

Public Meeting
27 June 2023

Impounded Supply Leaks

Temporary Repairs

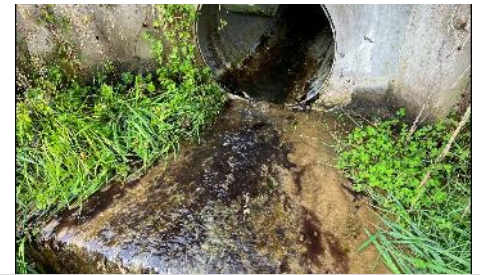
Impounded Supply Subsoil Drain Discharge Flow Rate (l/s)
10 June - 26 June 2023

- Slow but steady progress
- No deterioration of the eastern embankment (the dam wall) noted
- Subsoil drain outlet flow has reduced from ~25 litres per second to ~5 litres per second

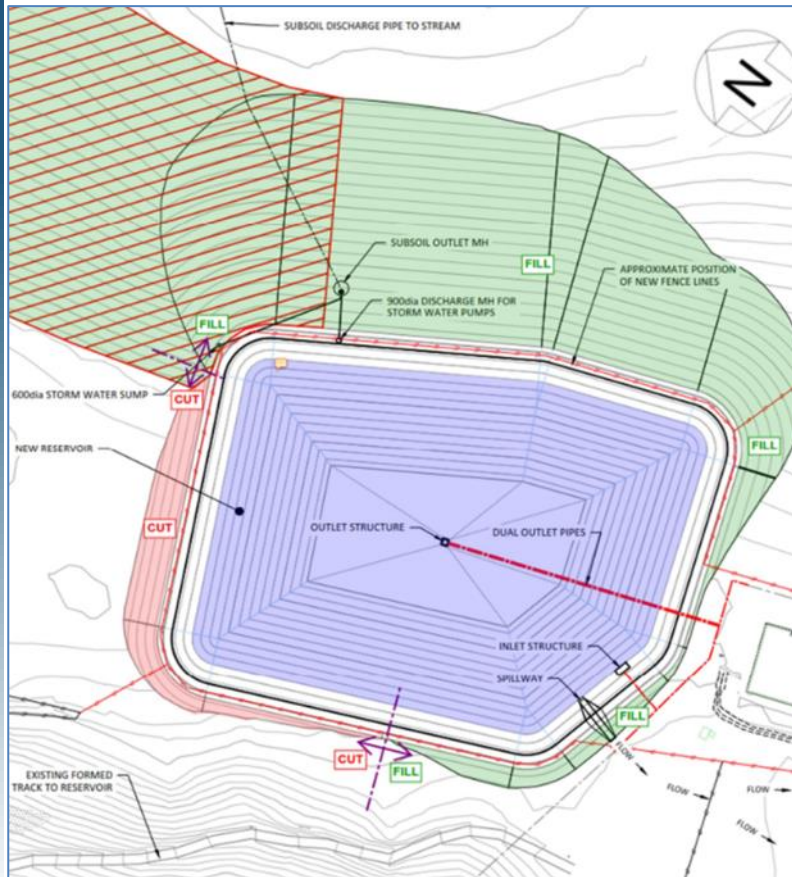
Full supply volume: 120ML

Full supply depth: 12m

Crest full volume: 160ML

Dam height (Building Act definition): 21m

Mostly an excavated pond except for a dam fill embankment on the eastern side.

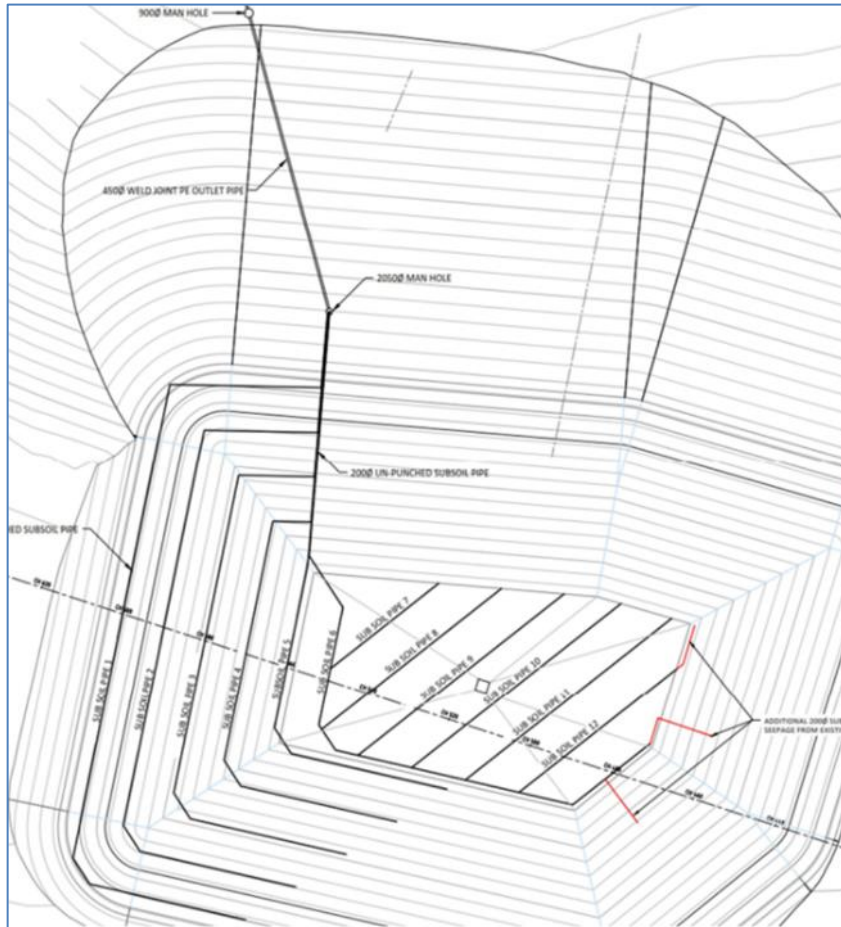
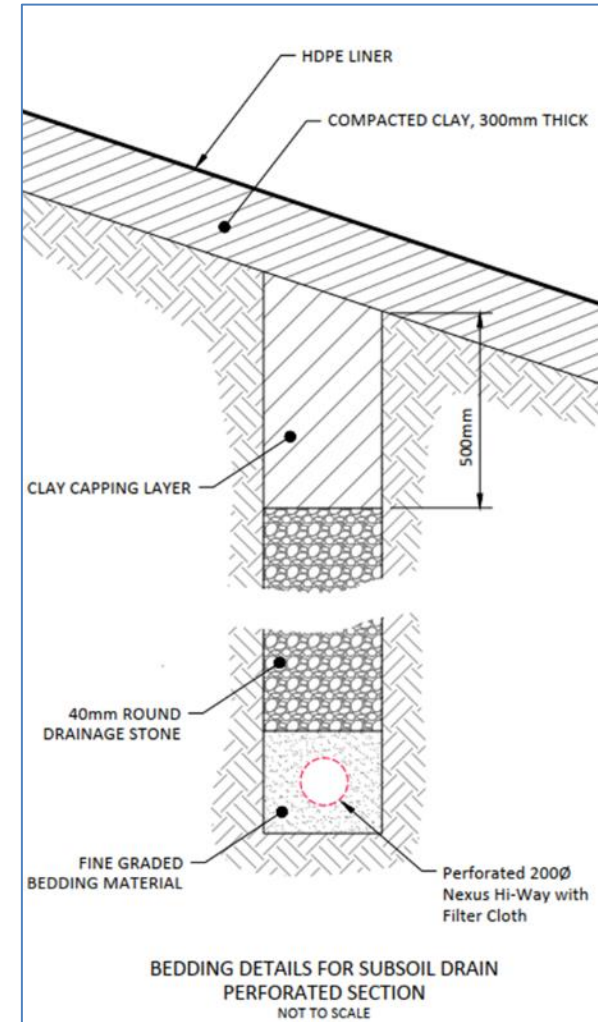
Liner =

- HDPE
- 300mm clay.

Subsoil drainage network under liner.
